# Lighting Characterization of the General Bank Operation Center in Panama

By Ana Gabriela Araúz, Cathleen Lee, Diego Segundo & Jorge Perém

*Universidad de Panamá*

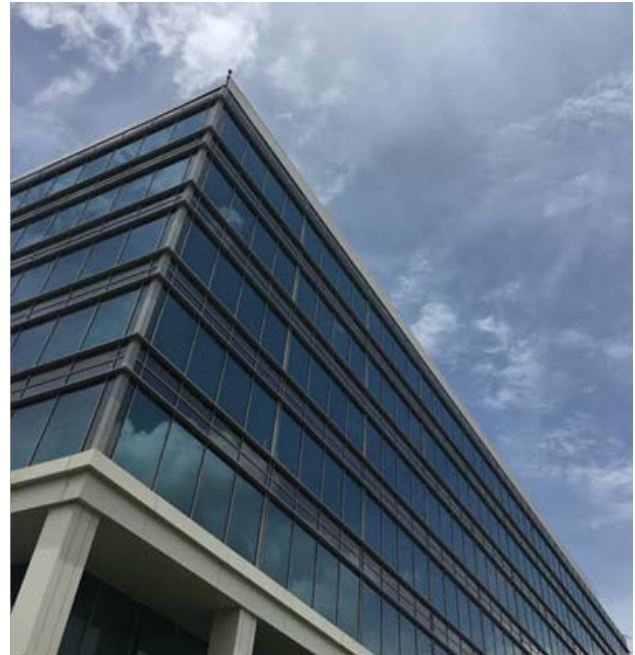
Fig. 1 Fotografía del Centro de Operaciones Banco General.

The case study for this research is the Bank Operations Center (*Centro de Operaciones de Banco General*) in Panama City, Panama (Fig. 1 and 2). It is an eight-story parallelepiped facing north with approximate dimensions of 85.00 m x 43.00 m. It has a control system for artificial lighting and blinds. The artificial lighting system for the most part works with Alera Lighting 28watt lights, *RI 85 (T5) Model CV-4-2T5-FCM18-ESD-MW* along with an electrical transformer (Lutron Ecosystems H-Series Dimming fluorescent ballast for T5 lights 28 watts) that regulates the intensity of the light depending on the global horizontal light (lx outside). Every light fixture is regulated by Quantum Vue software on each story.

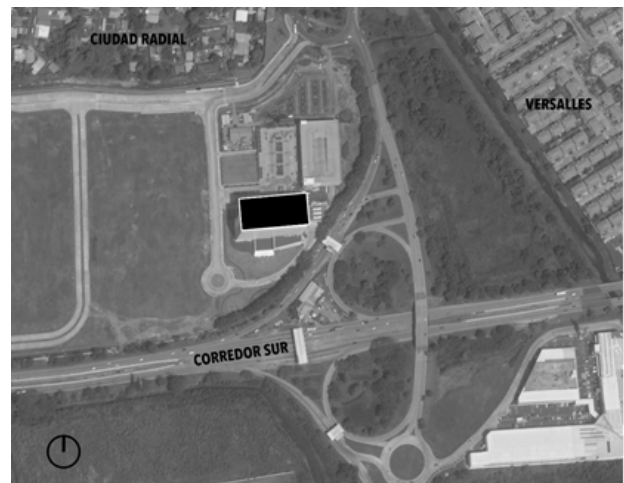
Fig. 2 Localización y orientación del caso de estudio, Centro de Operaciones Banco General, Ciudad Radial

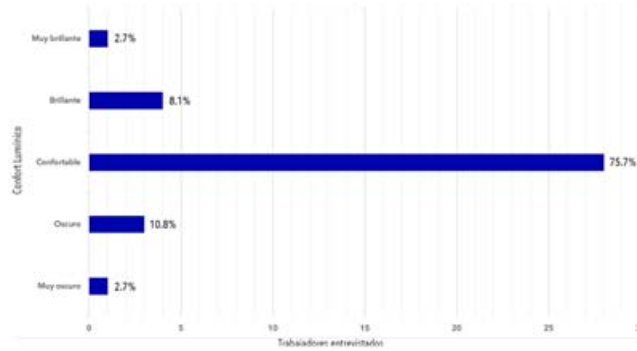
Fig. 7 Resultados de percepción de confort lumínico en puestos de trabajo.

A total of 37 surveys were completed throughout the study area. 75% of the surveyed users describe their work space as comfortable in terms of lighting (Fig. 7). As for performing tasks on the computer, 51% feel satisfied and 30% choose the

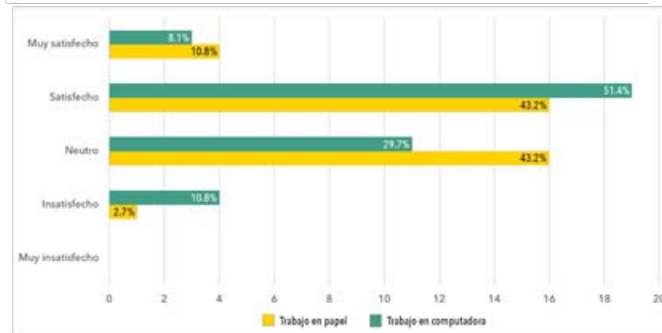
Fig. 8 Resultados de niveles de satisfacción para leer y escribir en computadora y en papel

neutral option. Regarding paper tasks, 43% say they feel satisfied and 43% choose the neutral option. (Fig. 8)

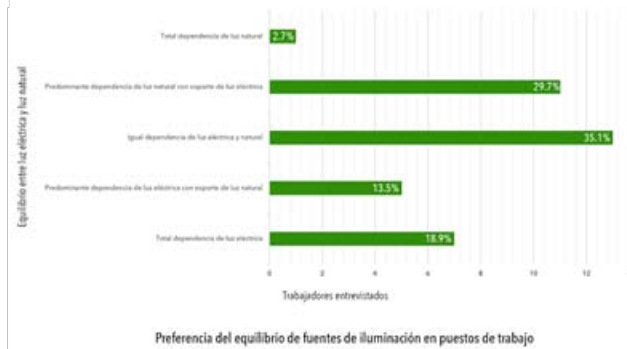
Fig. 9 Resultados de preferencia de fuentes de iluminación en puestos de trabajo

35% prefer equal dependence on electric light and natural light, followed by 30% who prefer predominant dependence on natural light with electric light support (Fig. 9).
