## Developing Kruger Shalati: The Train on the Bridge

**Abstract-** This is a case study on the development of the *Kruger Shalati: The Train on the Bridge*, a themed, luxury boutique hotel in Kruger National Park (KNP), South Africa. Two key drivers of this project were authenticity and a strong ethos for Environmental, Social and Governance (ESG). Considering the target market the hotel serves and the local situation, this case study explains why modular construction was better to build parts of the property, instead of using traditional in situ construction methods. It further explains how the hotel was built, and the challenges that had to be addressed to complete the project. Finally, it examines how the use of modular construction methods and the uniqueness of the project impacted the normal hotel pre-opening activities and ongoing hotel operations. This case study has been prepared after reviewing published materials about the project and extensively interviewing five senior members of the project team.

## A Unique Modular Hotel Construction Case Study in Kruger National Park

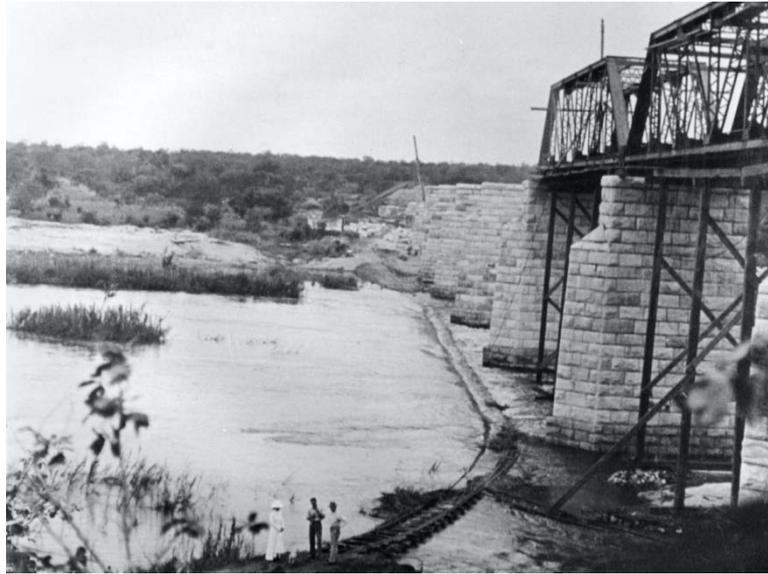
*Exhibit 8:* The Shalati Railway Bridge under construction

The 400-meter-long single line bridge dates from 1910, and consists of repeating steel-arched sections that span between 9 sandstone piers. It is a very early example of modular construction, wherein the steel sections were made in the United Kingdom and transported by sea and overland to the site before being craned into position on the locally built piers. The bridge has sweeping views and stands approximately 15 meters above the Sabie River, which is known for its crocodiles, hippos, buffaloes, and elephants. In addition, the area boasts abundant bird life.

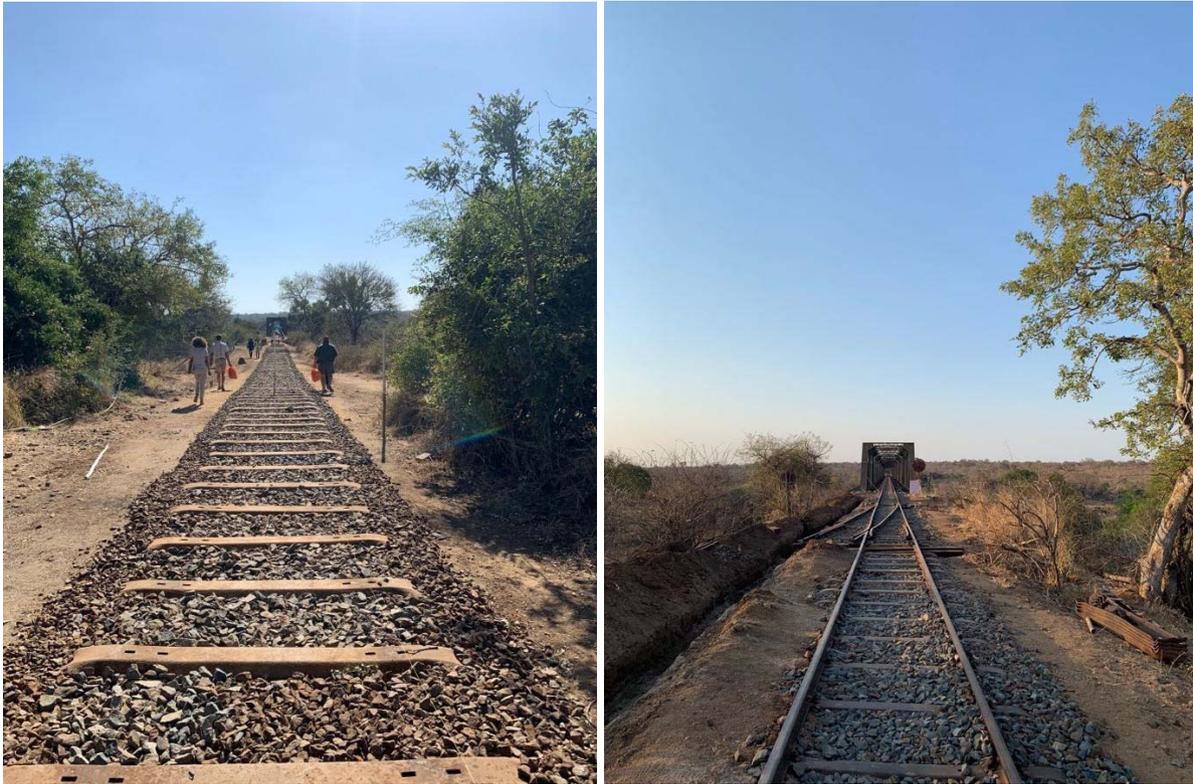
*Exhibits 9 and 10:* Adding the straight spur and switch

1. *Production:* Identify steel and carpentry works near Johannesburg, chosen for its industrial base (incl. mining), large population ( $\pm 5m$ ), intervening road infrastructure and relative proximity to KNP ( $\pm 400km$ ).
2. *Transportation:* Acquire a specialized large container transport vehicle with adequate lifting cranes to transport a single railway carriage, measuring  $\pm 25$  meters in length, over 4 meters in width and weighing 30 tons.
3. *Roads:* Investigate possible routes and limitations (e.g., size, access times, escort, etc.) outside and inside KNP.
4. *Tracks:* Add a straight spur and switch to the existing track between the bridge and station, as a railway carriage can only be mounted onto a straight length of the track. (*The space on the spur also allowed carriages to stack-up on arrival, for remedial works and fit-out, before moving them onto the bridge.*)

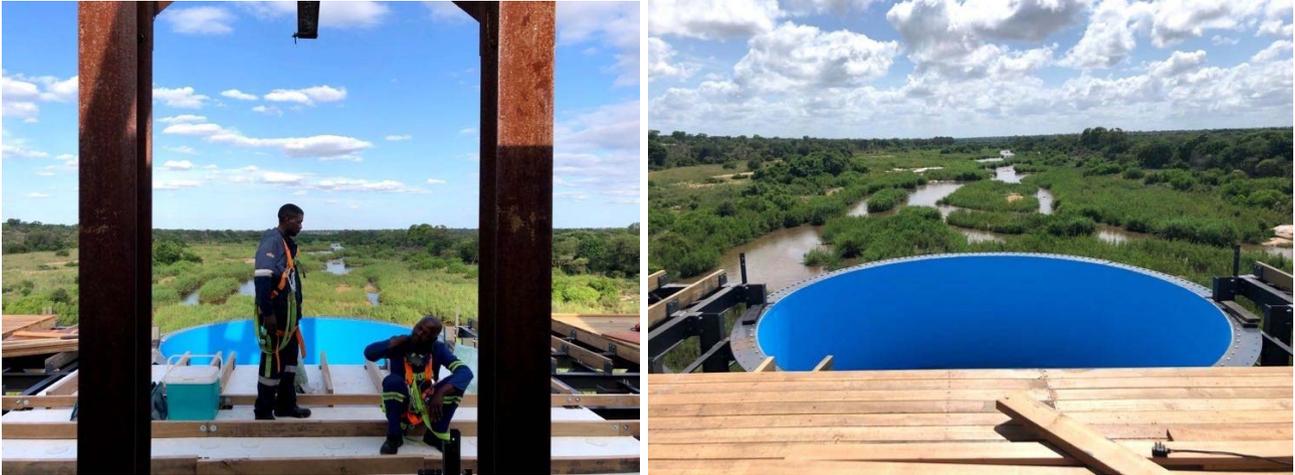
*Exhibits 11 and 12:* Suspended swimming pool under construction

To take better advantage of the dramatic views from the bridge and to increase the hotel's "Wow! factor", the project team decided to re-purpose the old steam train re-watering tower as a suspended swimming pool with a deck instead of demolishing it. The tower was 1/3 the way down the bridge and was not a historic landmark. Therefore, it could be altered and a deck could be added to link it to the bridge, on the condition that the deck could be removed at the end of the concession to restore the bridge to its original state.

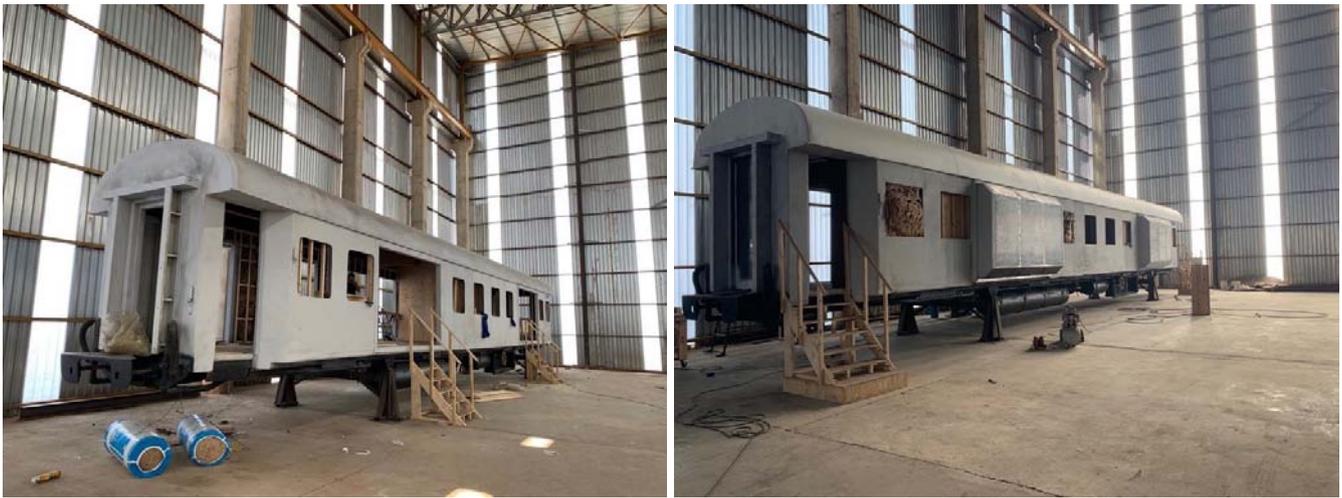
Exhibits 13 and 14: Welding panels and blisters to increase interior floorspace

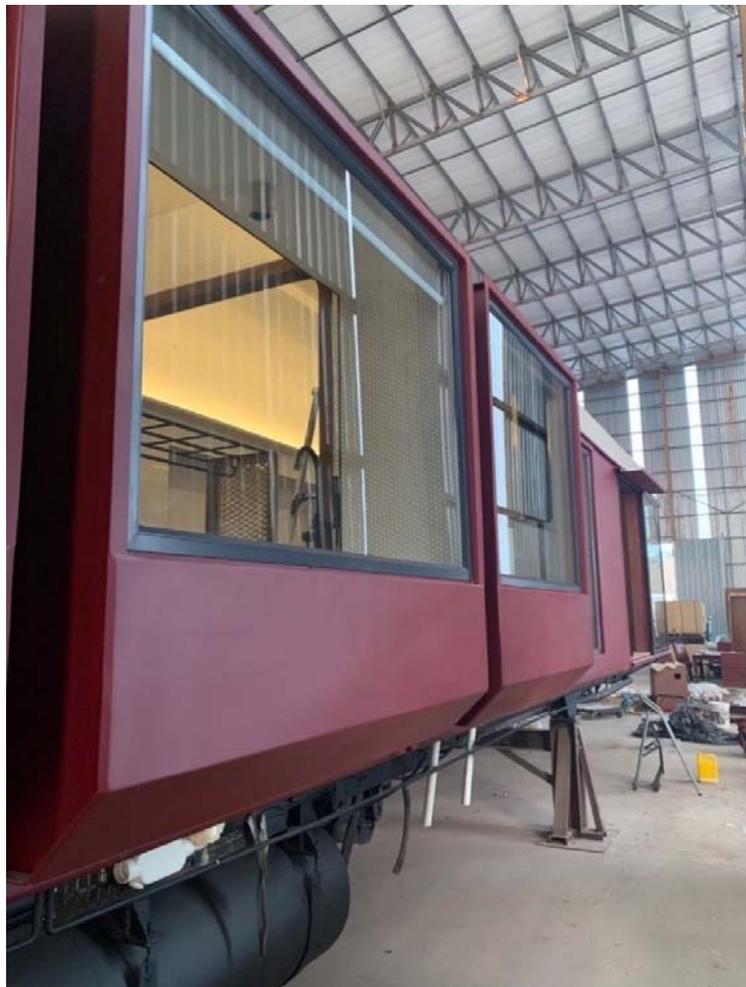
Exhibit 15: Blisters with windows added to the side of the carriage

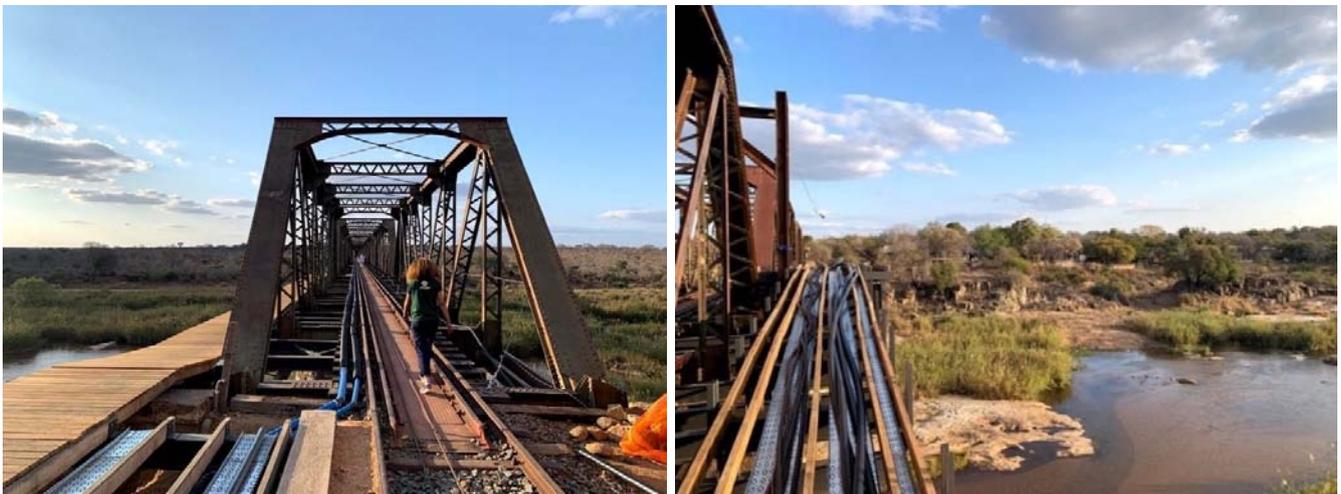
Exhibits 17 and 18: The service channels during installation on the western side of the train

2. A site survey showed that electricity, water, and sewerage services could be run within an existing service channel between the tracks along the bridge and underneath the external walkway. Sewerage was especially difficult to deal with and required making and installing removable, sealed holding tanks and pumping equipment on the bridge piers.

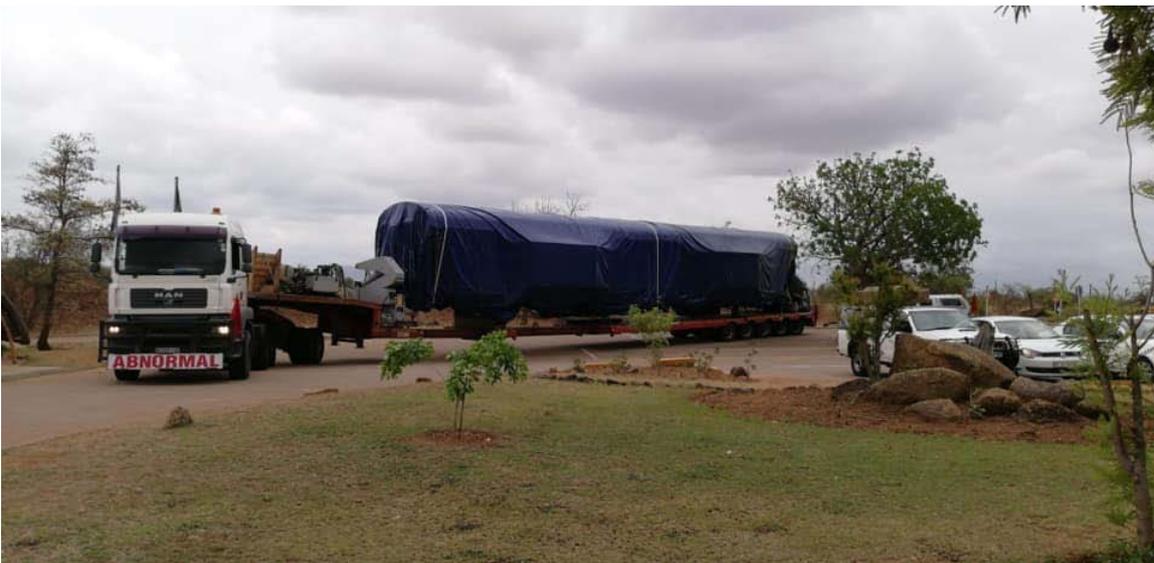
*Exhibit 21:* The multi-axle hydraulic low bed trailer with side-lifting, extendable arms

- **Registration:** The trailer is not a conventional low bed trailer but fits onto an intermediate wheelset that then connects to the truck tractor. It becomes a complicated rig, involving 3 vehicles, that must be registered with the Department of Transportation (DOT), Road Transport as a unit.
- **Restrictions:** The project team had to manage weight issues for the completed carriages, as well as weight restrictions per axle, height, and width restrictions on specialist trailers.
- **Regulations:** No special transports are allowed on weekends, public holidays, when it is raining, and on certain roads and routes. The truck must be escorted by vehicles in the front and back.

Transportation of the “prototype” carriage was proof of concept and took 3 days. It exposed height and weighbridge issues, cut corners and damaged bridges. Delivery of the last carriage only took 1 day and 4 hours.

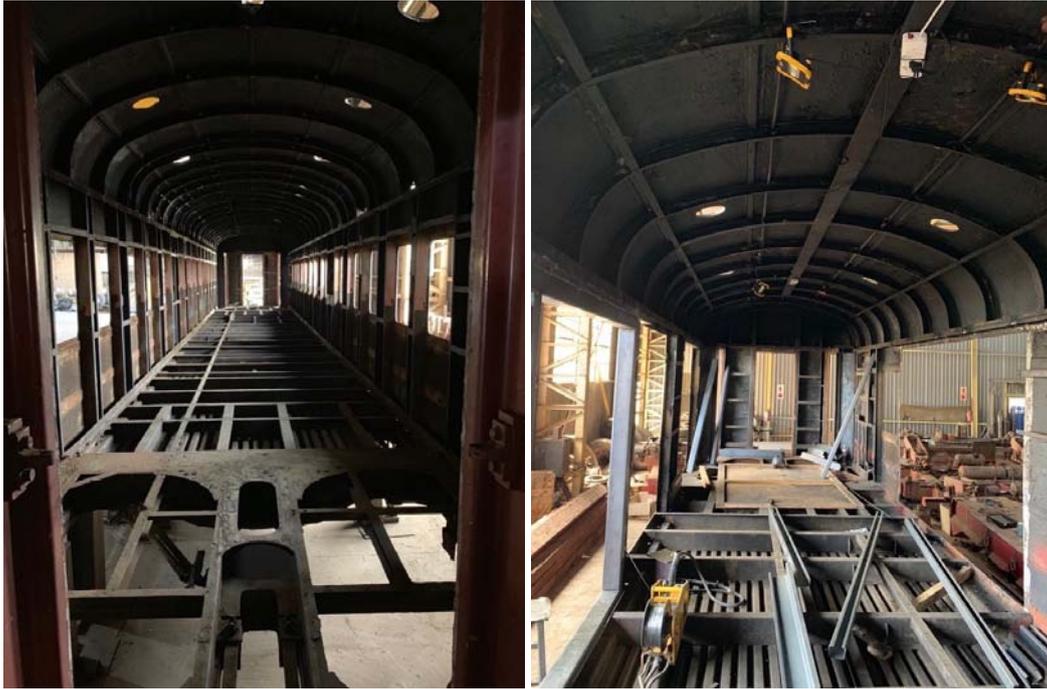
*Exhibits 22 and 23:* Carriage, gutted and ready for internal restructuring

A contractor in Ladysmith gutted and stripped down the selected carriages to their bare metal shells, and disposed of the internal compartments, gangways and scraps. Then, the wheel bogies were separated from the carriages, further reducing the weight, as well as the height for transportation to the steel workshop.

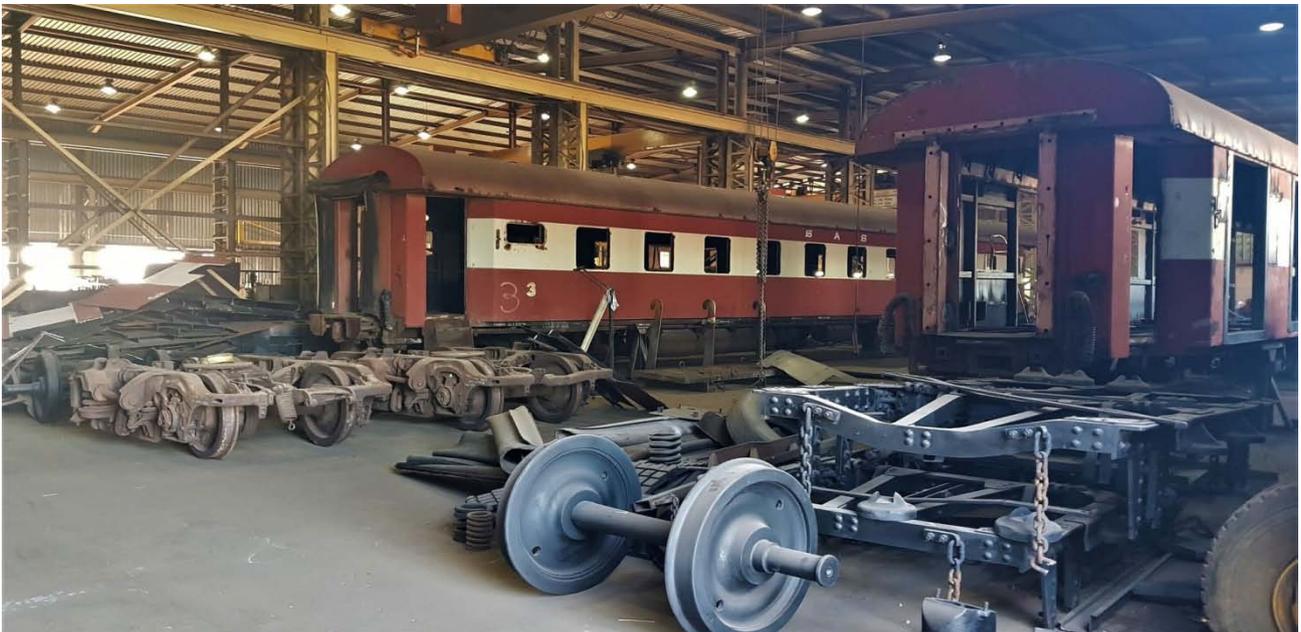
*Exhibit 24:* Carriage bogies, stripped and reconditioned

Each carriage was separated from its double-axle wheel bogies so that they could be reconditioned (i.e., checking the bearings, cleaning, painting and refurbishing). Each set of wheels was specific to a carriage and they were not interchangeable. Therefore, all sets of wheels were numbered and transported separately, to be laid out on the tracks, ready to receive the completed carriages in the right sequence.

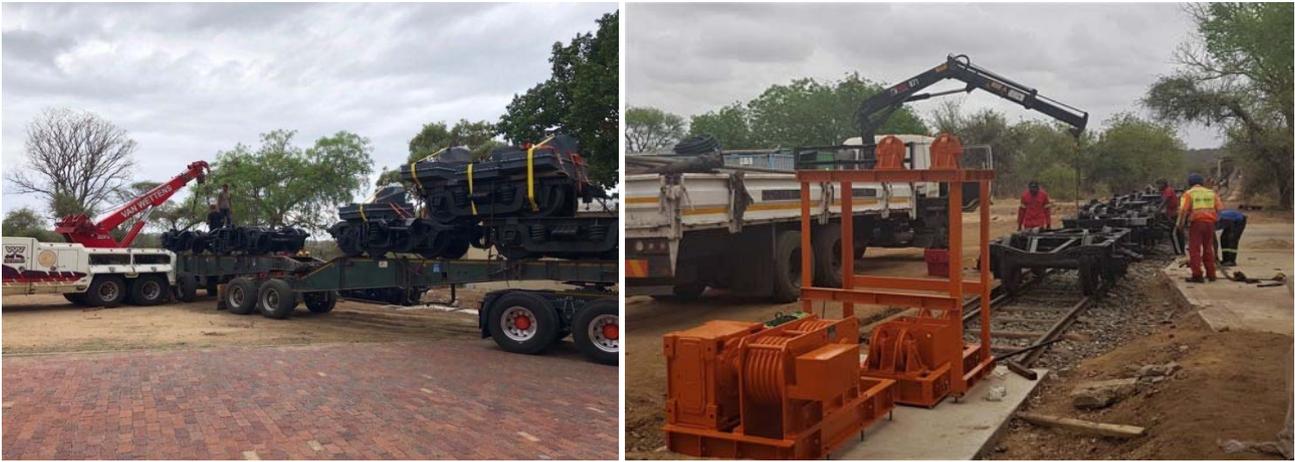
*Exhibits 25 and 26:* Carriage bogies delivered separately to site and laid in sequence on the track

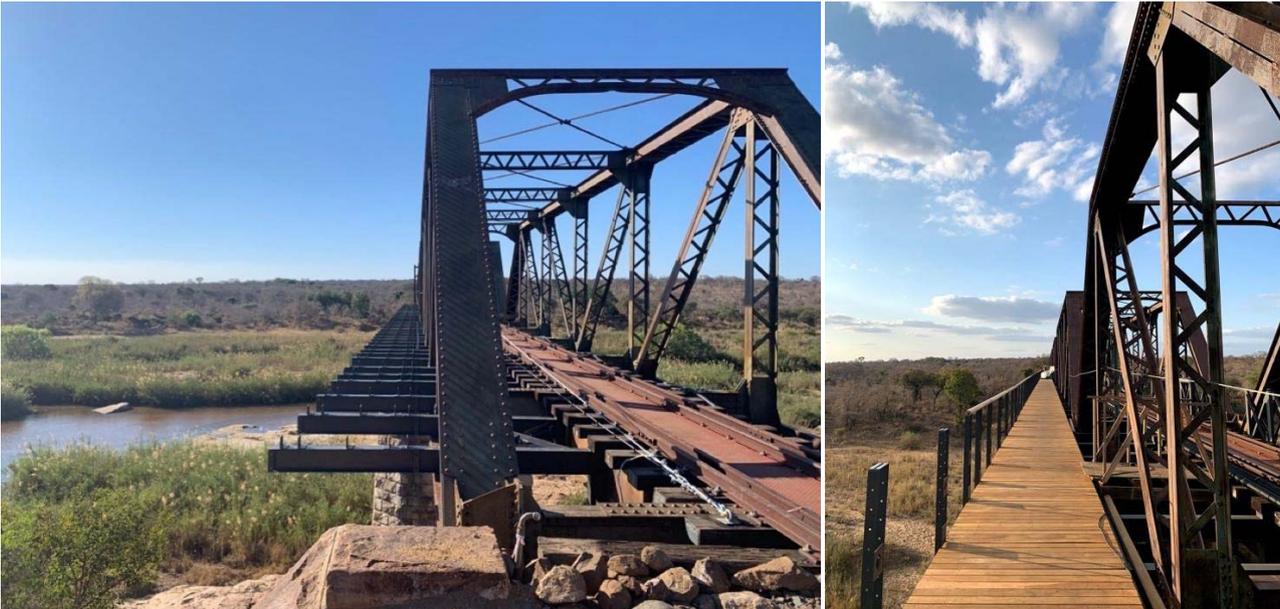
*Exhibits 27 and 28:* Installation of the external walkway

In parallel with the prototype, the rail spur line and the first sections of the external walkway were installed. At the same time, the holding tanks and service channel were manufactured and installed. Next, the first carriage was transported to the site and mounted onto its bogies on the rail spur line. Winches were used to drag the carriage into its final position, and it was permanently locked into place using wheel chocks clamped to the tracks. Lastly, utilities and other services were connected and the steps to the guest room entry doors were fitted.

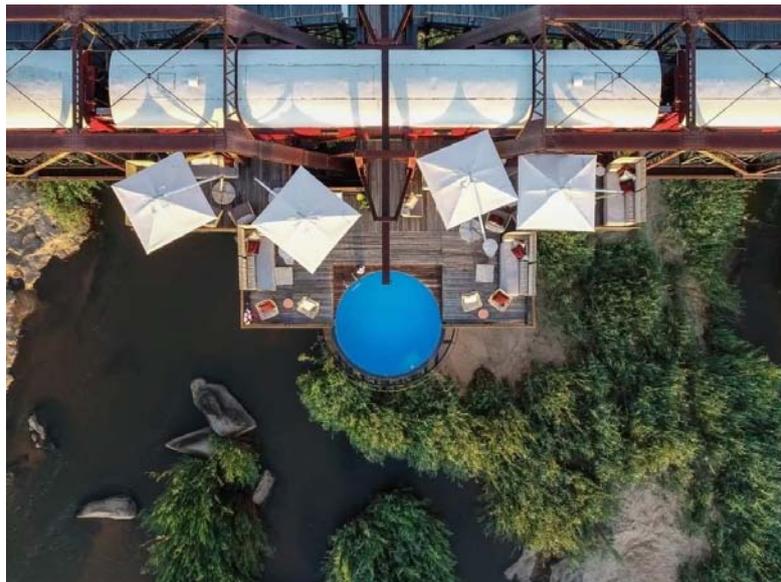
*Exhibit 29:* The lounge carriage and suspended pool

Once these and other significant prototype deficiencies had been identified and all the design challenges had been addressed, the design drawings were updated accordingly and communicated to the steel and wood workshops. Please refer to *Appendix B* for the TOB interior design drawing of a typical carriage guest room. The remaining carriages, including one with a Universal Accessibility (UA) guest room, accessible with a remote-controlled wheelchair lift from its end, rather than from its side, were then refurbished and delivered to the site sequentially in the order that they were to be positioned in on the bridge. As part of that sequence, the lounge carriage was prepared, which had to be perfectly aligned with the suspended pool, and therefore became the starting point for plotting the position of all other carriages. The mandatory dependency (datum) for positioning the first and furthest-most carriage was to ensure that when the lounge carriage was positioned, it was centred with the pool; it would have been virtually impossible to have to relocate 8 carriages down the line at that point. Please refer to *Appendix C* for the TOB interior design drawing of lounge carriage.

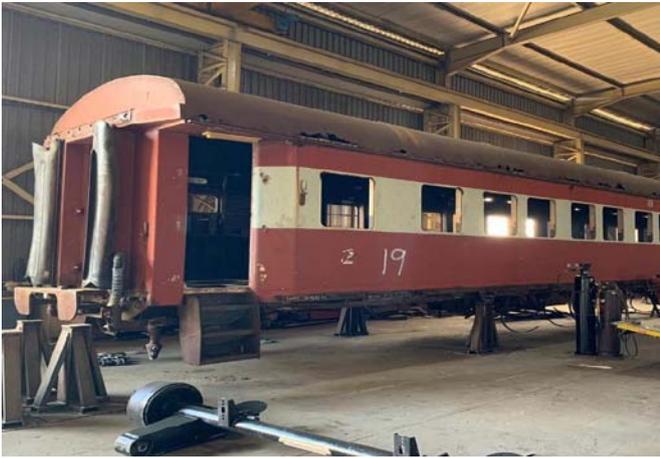
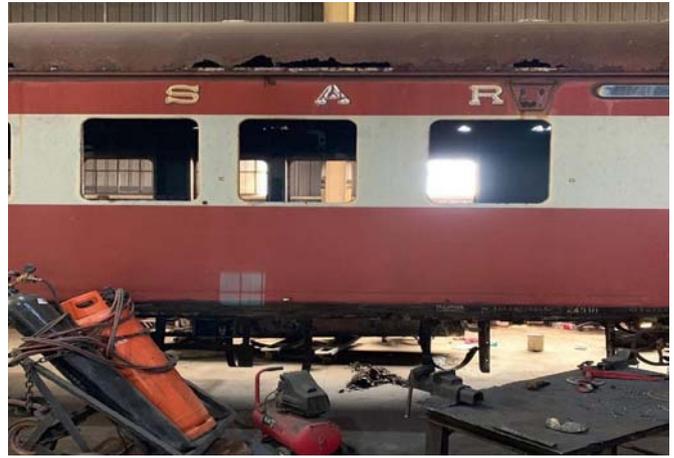
Exhibits 30 and 31: The first car in the steel workshop with bogies separated

Here, the team cut window openings, made structural reinforcements, fixed panels and spray painted the carriages, then moved the carriage to the wood workshop. One of the constraints of this facility was the maximum capacity of 5 carriages, which were rotated in and out on a 4 to 5 week cycle. The project encountered a serious challenge when it ran out of steel, during Covid-19, and a significant price increase once steel became available again.

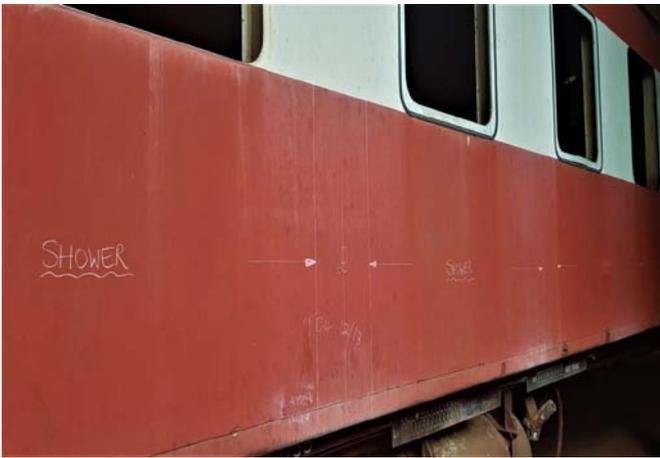
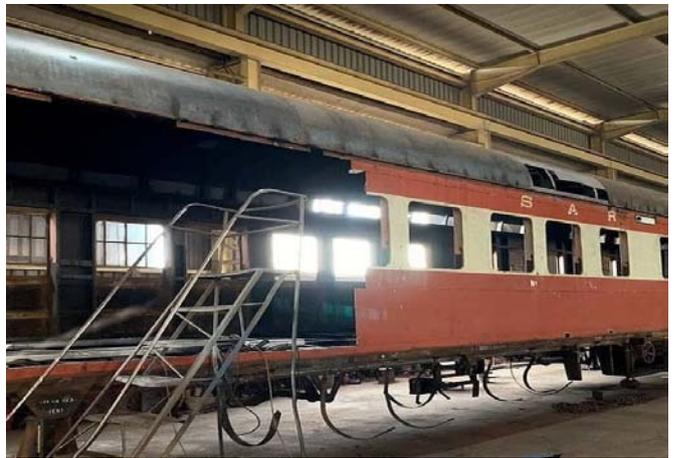
Exhibits 32 and 33: Setting out for the cut

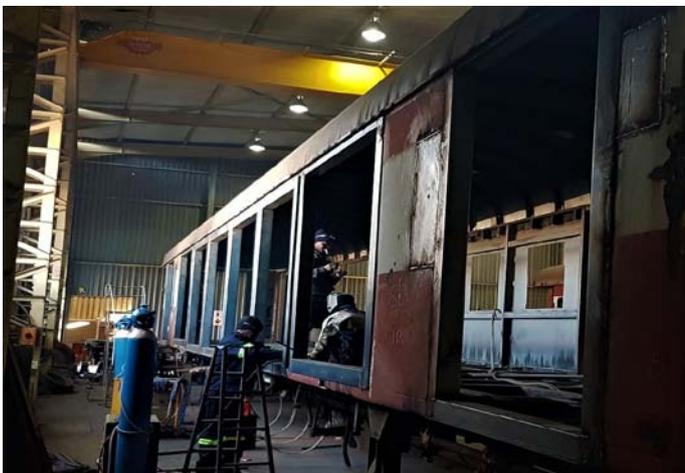
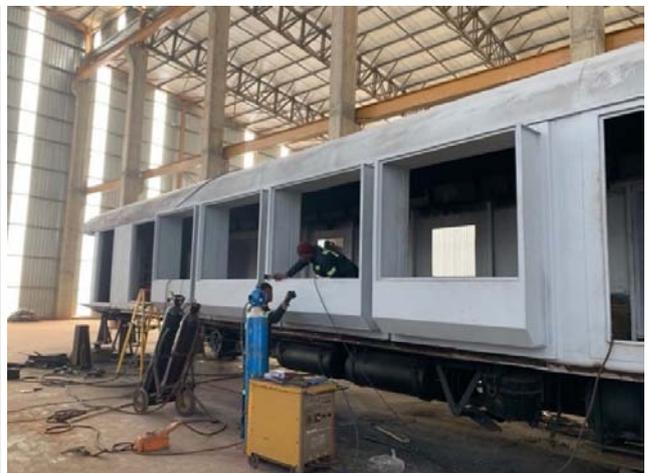
Exhibits 34 and 35: Picture window openings cut and framed

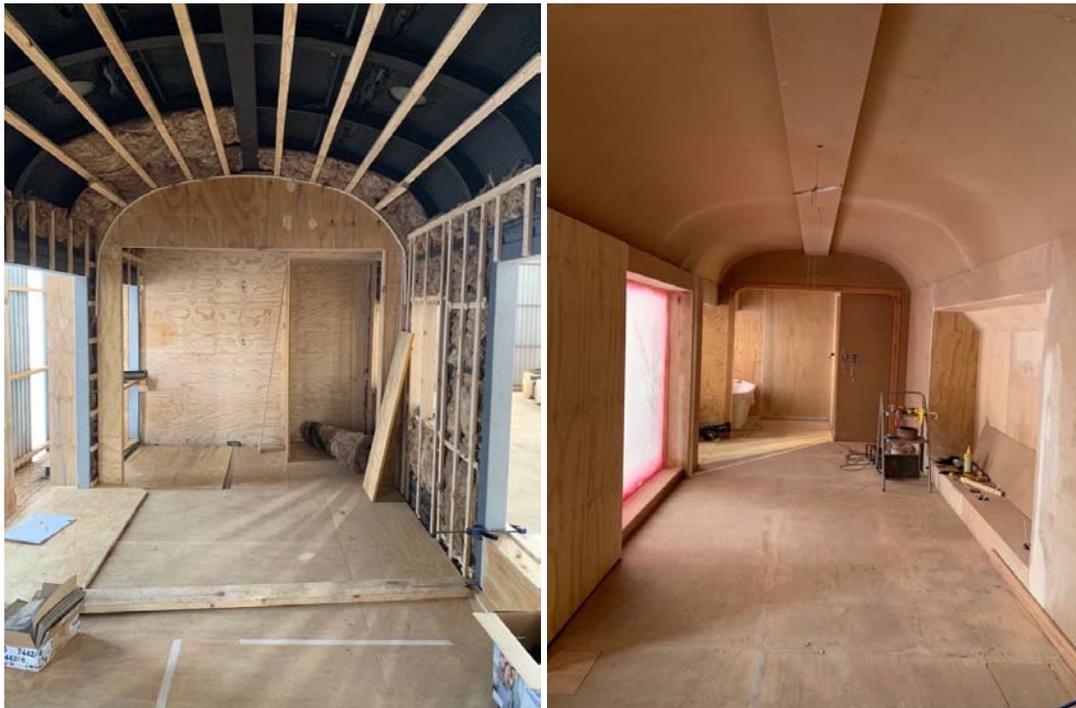
Exhibits 37 and 38: Internal structure before closure and panelling ready for wood finishing

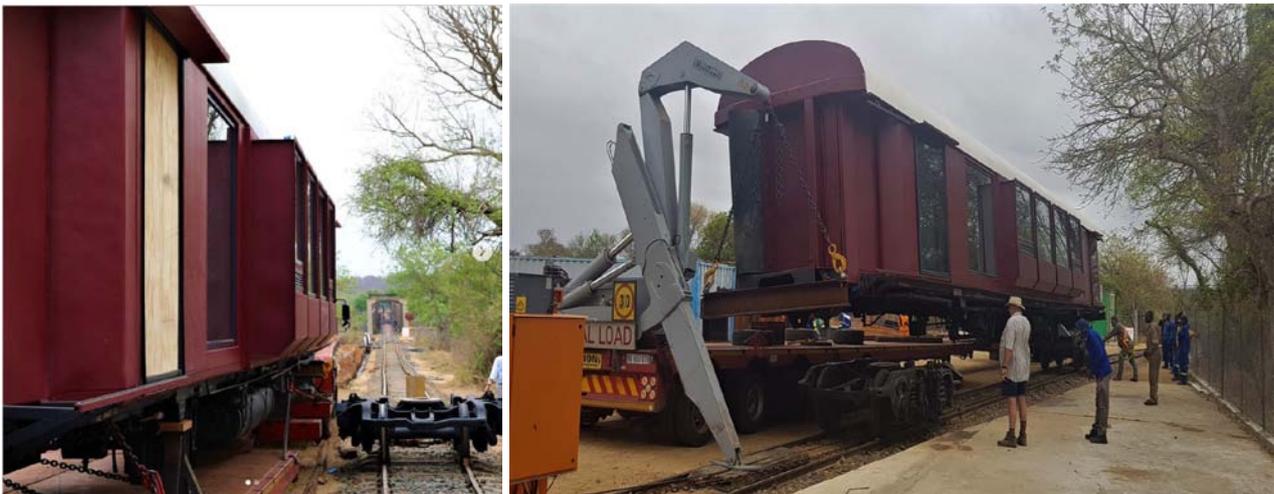
*Exhibits 41 and 42: The first carriage being hoisted back onto its original wheel bogies on the rail spur line*

As explained, the carriages were completed in the order that they were to be positioned on the bridge. Upon completion, each carriage was transported by road to KNP. Because of the size of the rig, SANParks only approved one access point into KNP, and imposed a special escort. Once the trailer was aligned with the spur, the carriage was hoisted back onto its original wheel bogies on the rail spur line and winched into final position on the bridge.

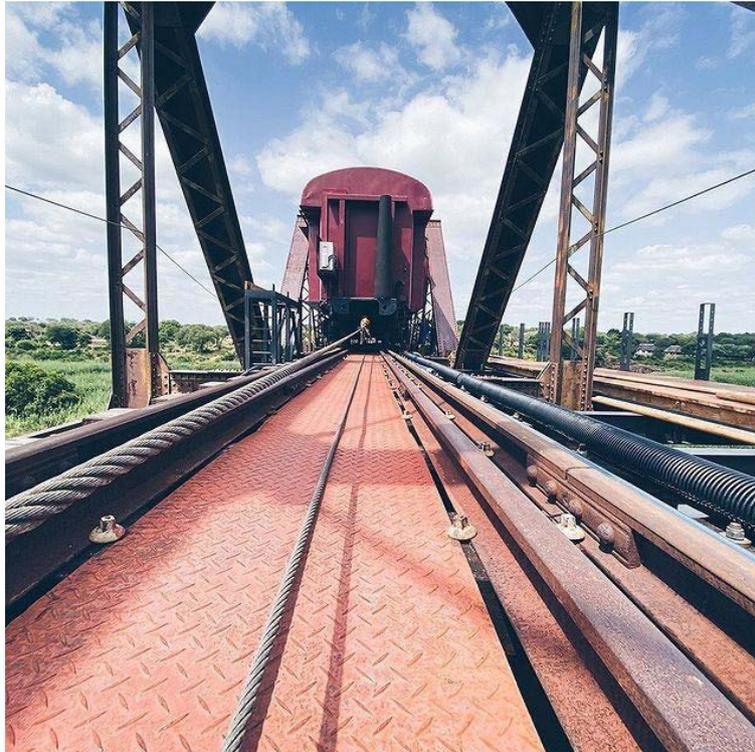
*Exhibit 43:* The first carriage being winched into position on the bridge

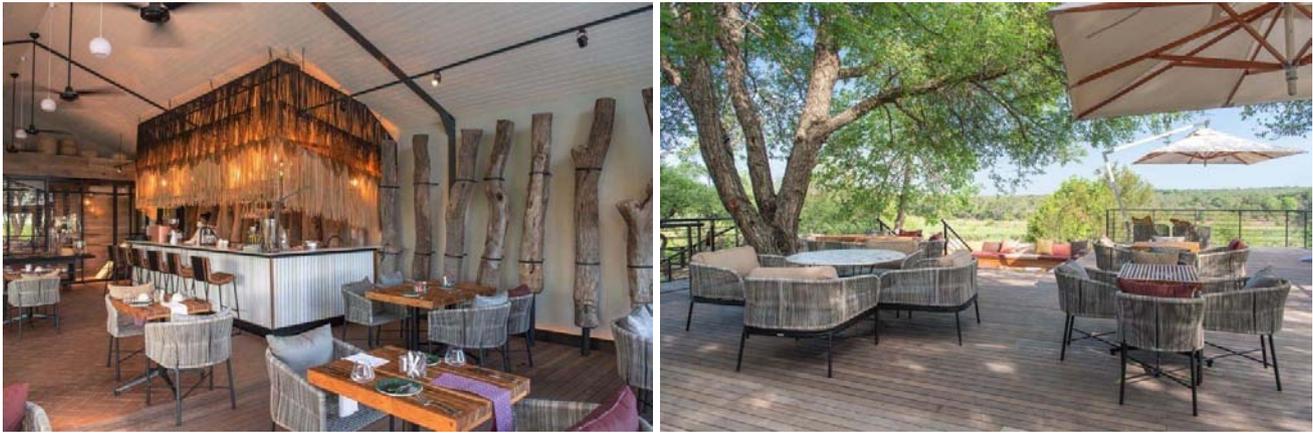
Exhibits 48 and 49: The Bridge House interior and exterior

- *Bridge House:* This facility was built using standard portal frames. This method is widely used in South Africa and was adopted for the design, but to a significantly higher standard of internal fit-out (e.g., the building was extensively insulated for guest comfort). This type of building fits in with the local architectural vernacular very well and it can be built quickly and efficiently. In addition, the semi-skilled labor needed for most of the work is readily available.

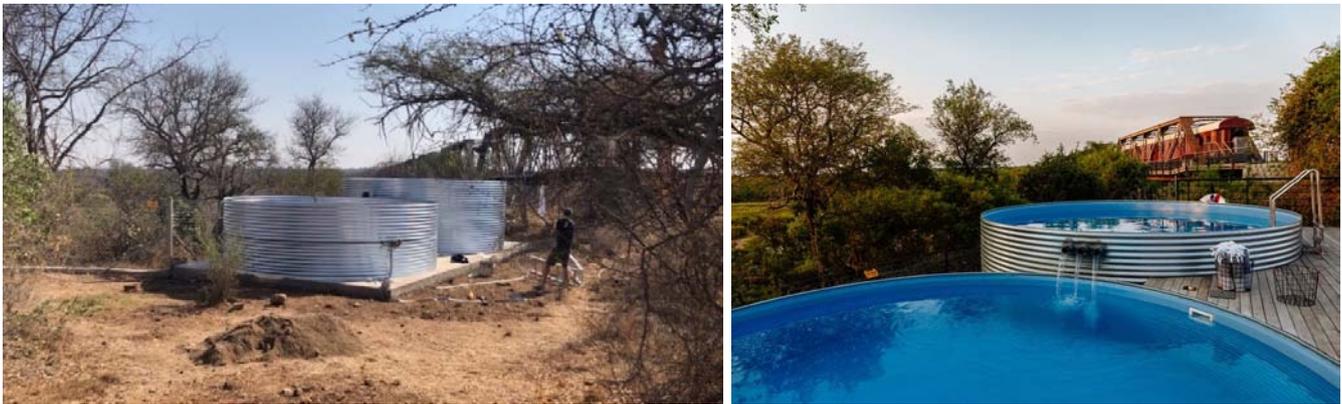
Exhibits 50 and 51: Assembly of the double swimming pool and completed project

- *Swimming Pool:* The double swimming pool, made from repurposed cylindrical water tanks, were installed adjacent to the Bridge House.

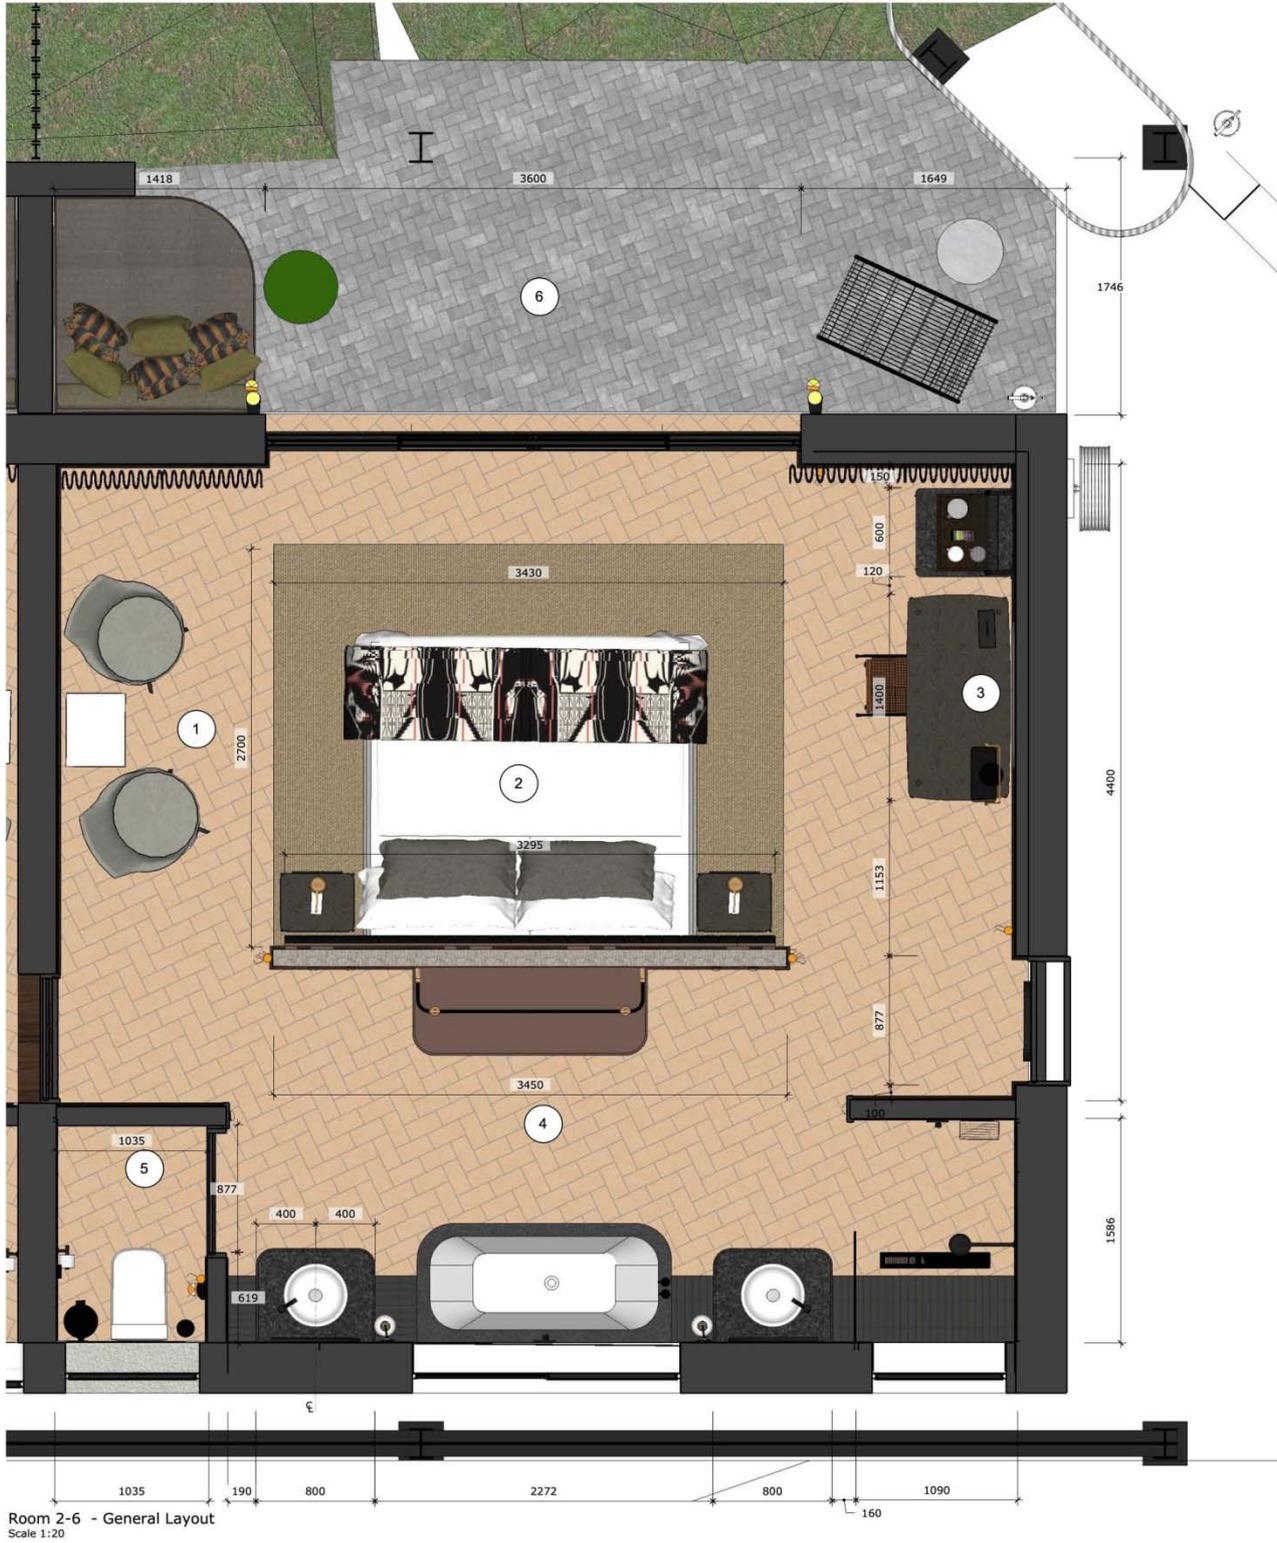
TOB interior design drawing of a typical non-carriage hotel room

prospective guests with acrophobia as well. Please refer to *Appendix D* for the TOB interior design drawing of a typical non-carriage hotel room.
