Behavior of I-Section GFRP Beam Including Retrofitting for Damage Effects

By Mamadou Konate & Zia Razzaq

Old Dominion University, United States

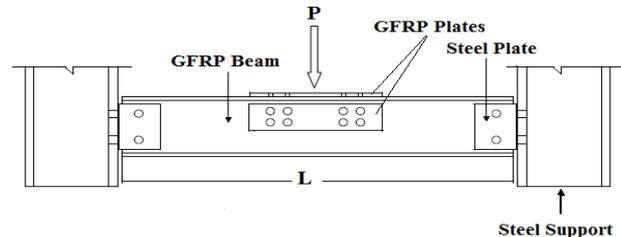
loads for a GFRP beam with and without GFRP retrofitting including lateral torsional buckling effects. Figure 1 shows the schematic of the GFRP beam of length L studied herein.

Fig. 1 : Schematic of GFRP beam

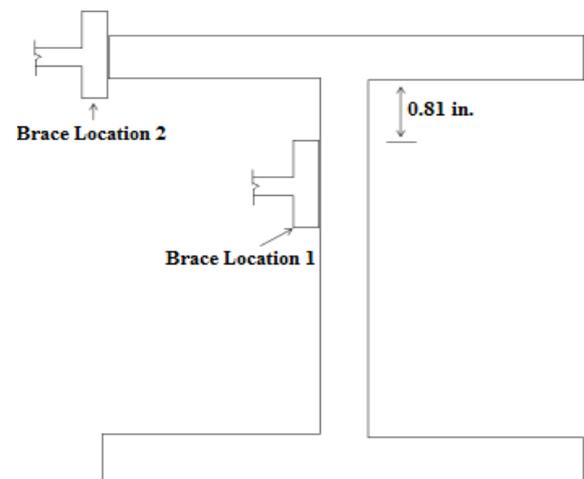
Fig. 2 : Cross section with alternative mid-span brace locations

Figure 7 shows a part of the retrofitted beam for Experiment 2. For Experiment 2, the arrangement for the dial gages, mid-span web brace Location 1 indicated in Figure 2, the applied load location, and the beam end connection remain the same as for Experiment 1. The resulting load-deflection curves for Experiment 2 are shown in Figure 8 showing a buckling load of 3,910 lbs.

The damaged GFRP beam with GFRP retrofitting tested in Experiment 2 is tested again in Experiment 3 in which the mid-span braces are located at the top flange indicated as Location 2 in Figure 2. In this experiment, the beam buckled at a load of 4,372 lbs. The load in Experiment 3 is approximately 12 percent greater than that found in Experiment 2 indicating a greater effectiveness of the brace at the top

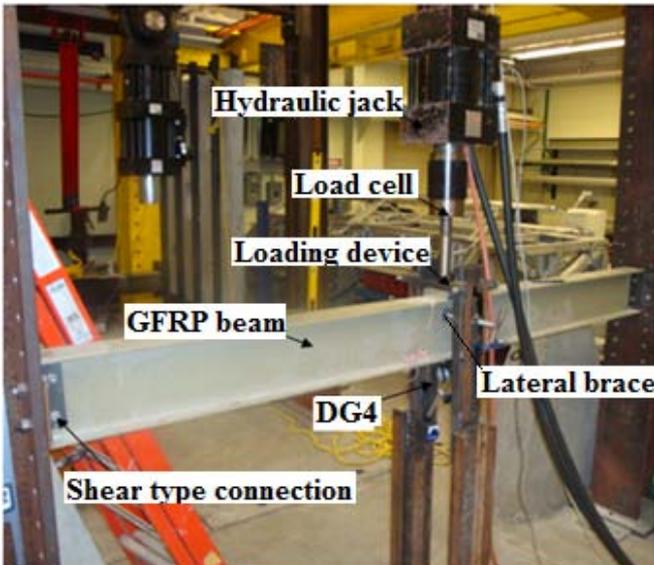
Three experiments are conducted using a GFRP beam with a clear length of 93 inches. The damaged GFRP is retrofitted with GFRP in the last two experiments. The load-deflection curves and the peak loads are recorded. Figure 3 shows the experimental test setup. In this figure, a dial gage (DG4) is also shown which is used to record the mid-span vertical deflection. A total of seven dial gages were mounted to record both vertical and lateral deflections. A hydraulic jack of 50-kip capacity with load cell and a loading device are also shown in Figure 3.

Fig. 3 : Experimental test setup

The hydraulic jack is controlled by the system console. This arrangement gradually transmits load from the hydraulic jack to the GFRP beam. The test procedure involved applying the load, P , in small increments and recording the resulting deflections. The loading process is continued until the member's load-carrying capacity is reached.

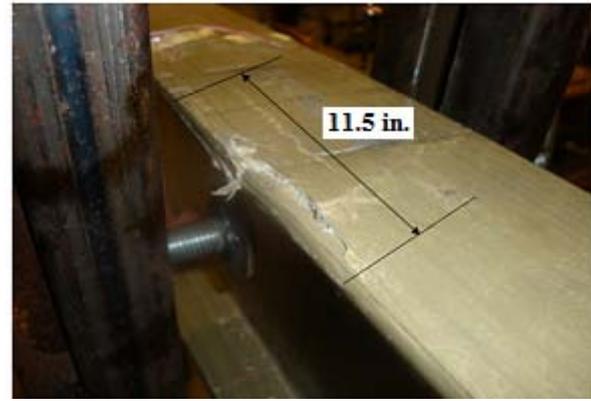
The mid-span web brace is provided on both sides of the web at 0.81 in below the bottom surface of the top flange. When approaching failure, the GFRP beam first buckled and then cracked. Figure 4 shows the view showing the top flange cracks and length of the GFRP beam. The buckling mode observed in the horizontal plane was S-shaped. The beam developed lateral-torsional buckling at a load of 8,426 lbs, and subsequently cracked at a load of 8,542 lbs. The beam exhibited elastic behavior up to the attainment of buckling load. Figure 5 shows the beam load-deflection curves of the GFRP beam for the lateral deflection (DG2) and the vertical deflection (DG3) both at the beam quarter length from the left support, and for the mid-span deflection (DG4).

Fig. 4 : Top flange GFRP beam cracking in Experiment 1

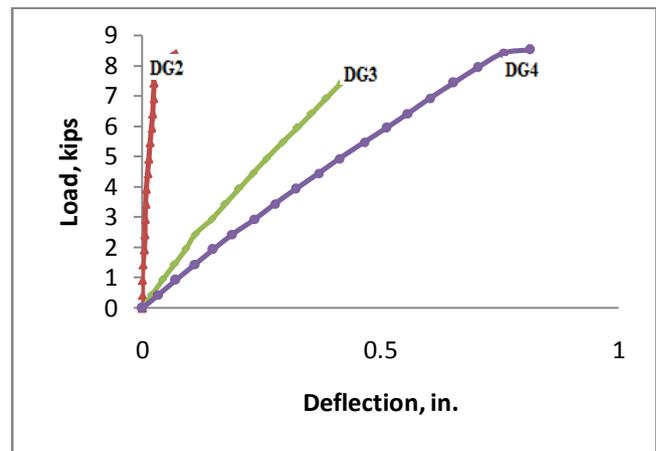
Fig. 5 : Load-deflection relations for Experiment 1

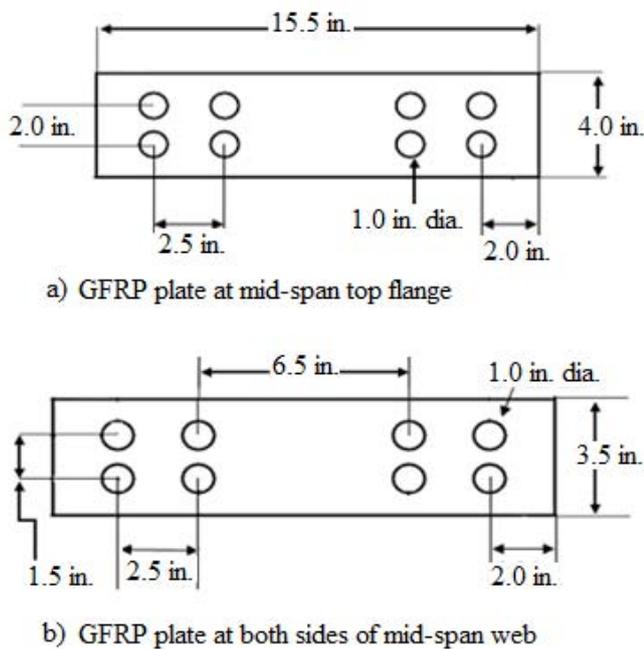
The GFRP damaged beam from Experiment 1 is first retrofitted with CFRP plates on both sides of the web and top flange and then re-tested. Figure 6 shows the GFRP plates used to retrofit the mid-span top flange and two sides of the web, respectively. The plates were 0.5-inch thick and mounted to the beams using 0.875-inch diameter steel bolts.

Fig. 6 : GFRP retrofitting plates used at mid-span

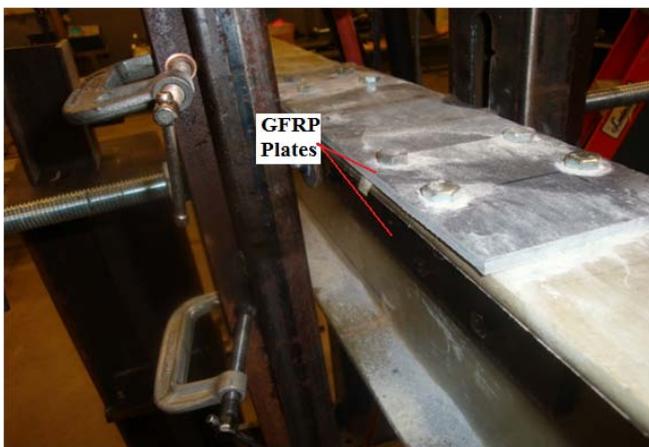
Fig. 7 : Retrofitted damaged beam

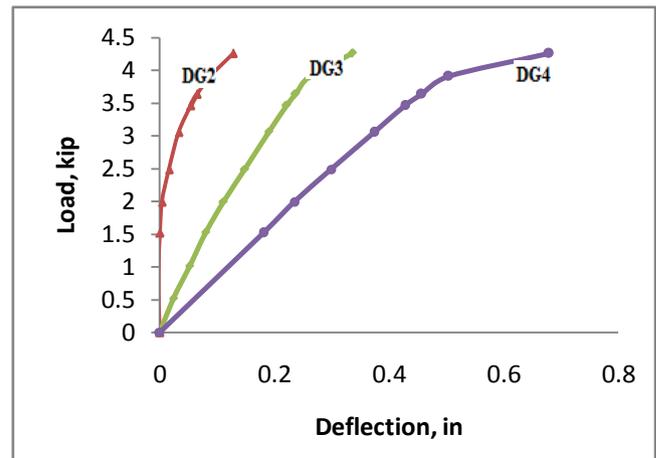
Fig. 8 : Load versus deflection relations for Experiment 2

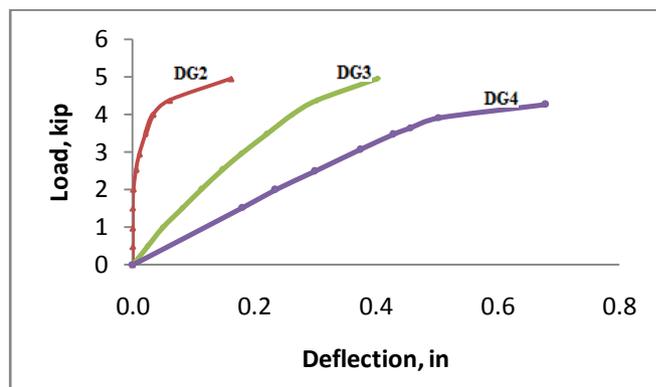
flange as compared with the one on the web. Figure 9 shows the load-deflection relations obtained for Experiment 3.

Fig. 9 : Load versus deflection relations for Experiment 3
