# Monitoring of the Hill and the Circuit Wall of the Athenian Acropolis Utilizing Optical Fibre Sensors and Accelerographs

By Dr. Elena Kapogianni, Dr. Kalogeras Ioannis, Dr. Prodromos Psarropoulos,  
Dr. Nikolaos Melis, Ms. Vassiliki Eleftheriou & Professor Emeritus,  
Michael Sakellariou

**Abstract-** The Acropolis of Athens is one of the most prestigious ancient monuments in the world, attracting daily many visitors, and therefore its structural integrity is of paramount importance. During the last decade an accelerographic array has been installed at the Archaeological Site, in order to monitor the seismic response of the Acropolis Hill and the dynamic behaviour of the monuments (including the Circuit Wall), while several optical fibre sensors have been attached at a middle-vertical section of the Wall. In this study, indicative real time recordings of strain and acceleration on the Wall and the Hill with the use of optical fibre sensors and accelerographs, respectively, are presented and discussed. The records aim to investigate the static and dynamic behaviour – distress of the Wall and the Acropolis Hill, taking also into account the prevailing geological conditions. The o

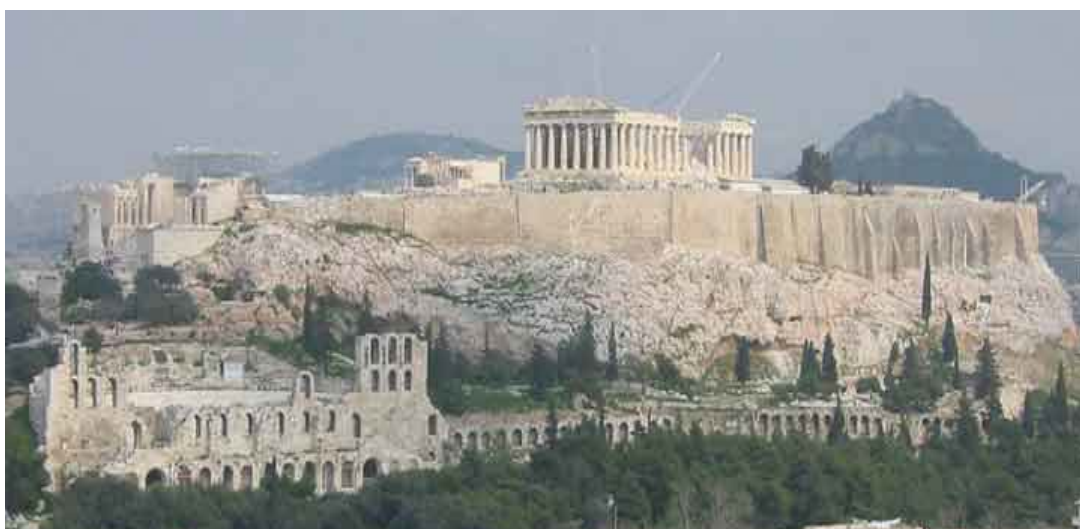
*Figure 1:* Panoramic view of the Athenian Acropolis, where the South Wall (right) and the West Wall (left) are shown

Athens. Among the standing monuments of the Hill, the Circuit (perimeter) Wall serves a pure geotechnical purpose, since it functions as a typical gravity wall, retaining the backfill that forms the plateau of the Acropolis and has total length of about 800 m and variable height areas 5-20 m. In Figure 1, a panoramic view of the Acropolis Hill from the south-east is depicted.

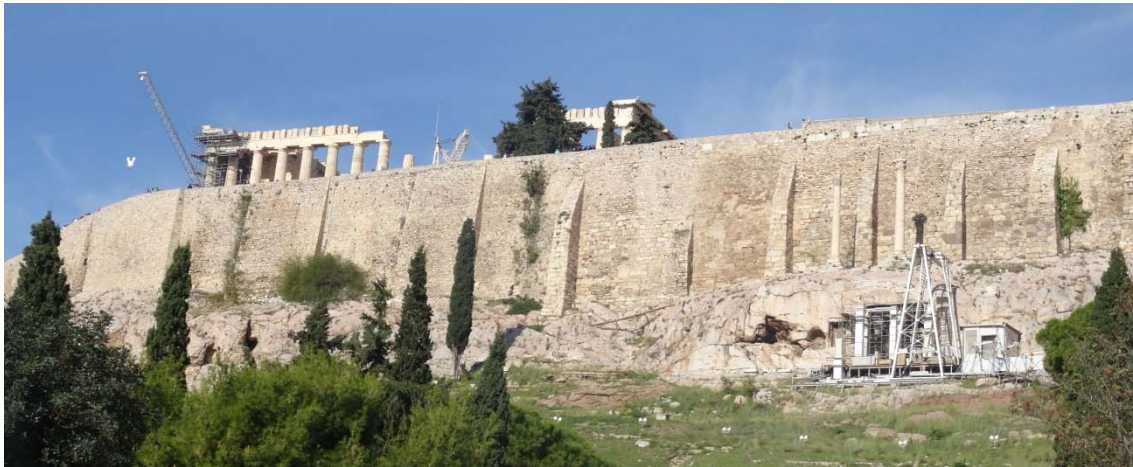
Figure 3: Central area of the South Wall on the Acropolis Hill

therefore increasing the risk of local and/or extensive structural failures (Ambraseys, 2010; Trikkalinos, 1977). In Figure 3 the central area of the South Wall is noted, which comprises mainly irregular mixed courses made up of ancient marble blocks in second use (spolia) and small stones, added in later repairs.
