# Monitoring of the Hill and the Circuit Wall of the Athenian Acropolis Utilizing Optical Fibre Sensors and Accelerographs

Dr. Elena Kapogianni<sup>1</sup>, Dr. Kalogeras Ioannis<sup>2</sup> and Dr. Prodromos Psarropoulos<sup>3</sup>

## Abstract

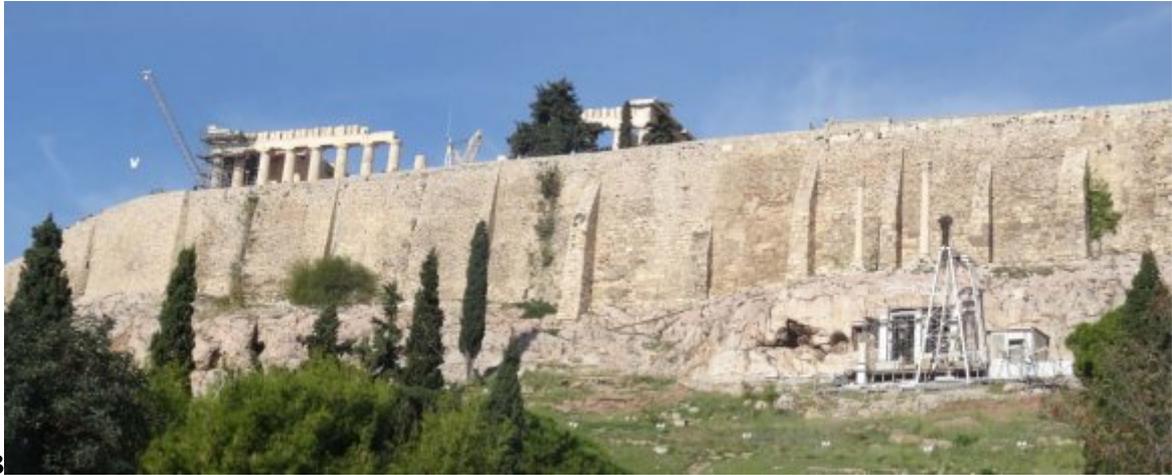
Figure 3: Figure 3 :

59 In Figure 3 the central area of the South Wall is noted, which comprises mainly irregular mixed courses made up  
 60 of ancient marble blocks in second use (spolia) and small stones, added in later repairs. ). The sensors were fixed  
 61 at predefined positions on the South Wall with the use of stainless steel plates, anchored to the substrate. The  
 62 critical positions of the optical fibre arrays were defined by analyzing computational models, utilizing the finite  
 63 element method (Kapogianni et al., 2017) and the area selected for the final installation was near the preexisting  
 64 accelerometers ACRD and ACRJ (see Figure 4). Connection in series was achieved via in situ splicing, while  
 65 strain measurements were made possible with the use of the Optical Sensing Interrogator SM 130. In Figure 5  
 66 the location of the new measuring equipment is presented.

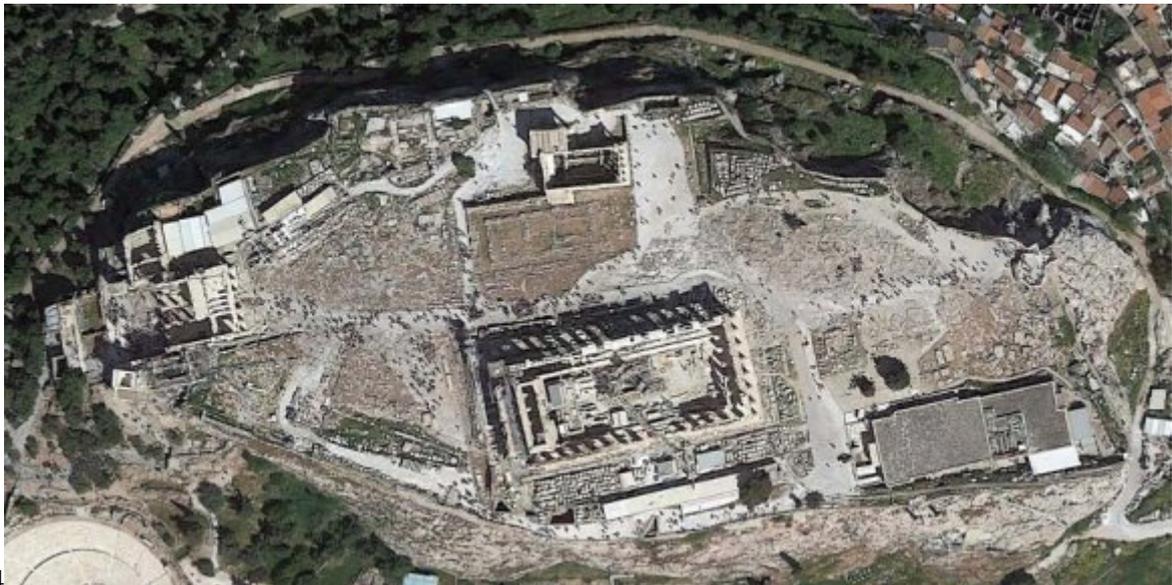
Figure 4: Figure 4 :
