Methodological Strategies for the Reconstruction and Sustainable Improvement of the Habitat of Localities in the State of Chiapas, Mexico

Abstract

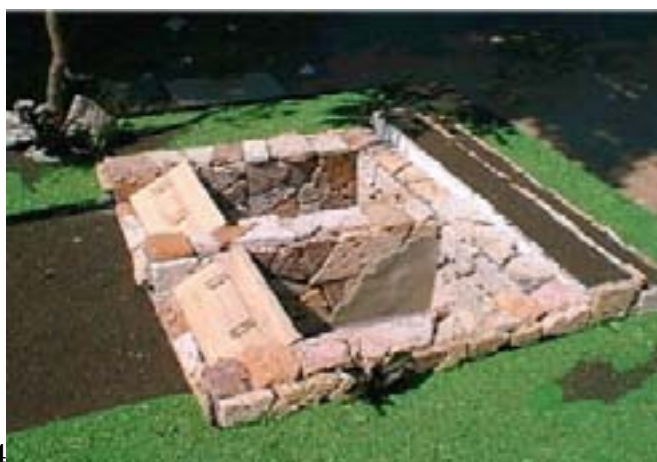
Figure 1: Image 4 :

207 Agriculture is the main economic activity, they grow coffee, corn and beans. In study, 3 main problems were
208 identified: Access road (2.2 km of road in poor condition), health service (clinic, with only a medical assistant
209 and midwife) and agricultural production marketing (lack of transport). Of the houses: 34.6% in floor of soil,
210 64.4% do not have sanitary furniture, more than 30% do not have sanitary furniture or body grooming area, etc.
211 (see image 4). The source of water supply is a spring, the water is not drinkable and is supplied by surface hoses,
212 they have no sanitary drainage network or public cleaning service, among others (see image 4).

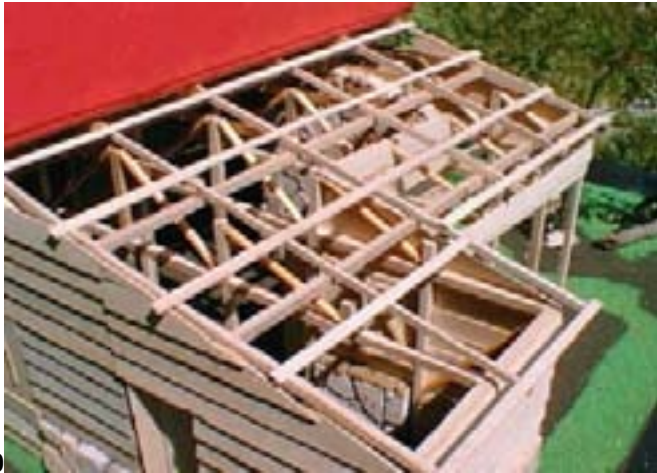
Figure 3: Image 10 :

246 Identified the elements to be transformed (image10), Joaquin's family built their home in 10 months, which
247 included training, advising and supervising the work, which ended in "time one (t 1)". The research project
248 financed the materials used: cement, reinforcing steel, etc. The labor, for the extraction of stone and sand from
249 the place and the construction, was in charge of the family.
