## Seismic Hazard and Total Risk of Existing Large Dams in the Marmara Basin, Turkey

By Hasan Tosun  
*Osmangazi University*

**Abstract-** Safety evaluation is a fundamental stage of existing dams and their appurtenant structures, which have a high-risk potential for downstream life and property. Turkey is a country, which seismically settled at one of the most active regions in the world, and earthquakes with high magnitude frequently occur here. There are some regions, which are severely under threatening of earthquakes. One of them is the Marmara region with twenty-four million people. This region, namely the Marmara basin, has at least forty-five large dams with different types. This study considered nineteen of them to relieve their seismic hazard parameters for all dam sites and total risk for each structure. The study area is lying in a seismically, very active part of Turkey. The southern part of the basin is structurally cut by the North Anatolian Fault, which is a famous structural feature that produces deathful earthquakes, and its offshoots. The analyses have indicated that peak acceleration widely ranges for the nineteen dam sites of this basin. The total risk analys

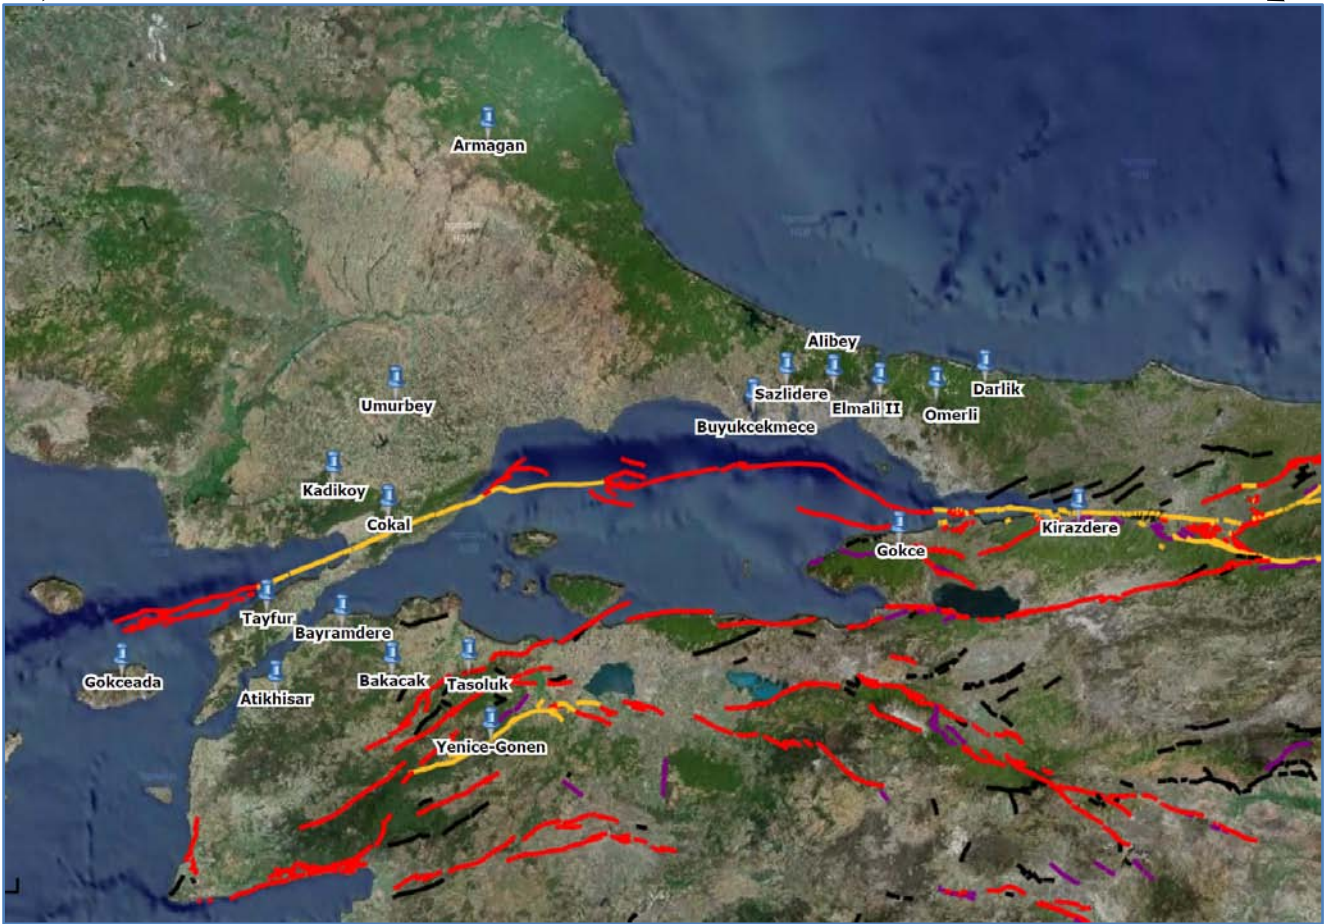
Figure 1: Location of dams on the national seismo-tectonics model and the active fault map (Active faults-yellow color: earthquake surface fracture, red color: Holocene fault, purple color: Quaternary fault, black color: possible Quaternary fault)

The study considers existing large dams in the Marmara basin, which covers lands around the Marmara Sea in Turkey (Fig.1). This basin has a surface area of 2.31 million ha with a water yield resources of 8.3 billion cu.m per year at the Northwest Anatolia. This study deals with an assessment of seismic hazard and total risk, and evaluates 19 large dams, which have a hydraulic height between 10.1 and 109.0 m, in the Marmara basin. Table 1 shows their technical characteristics. There are twelve large dams in the basin for providing domestic water to the Istanbul Metropolitan area in which seventeen million people are living. However, the existing dams in the Northern part of the basin, which were constructed by the Istanbul Water and Sewerage Administration, were excluded in this study because of being lack of data.

In Turkey, The National Geological Survey released a new seismo-tectonic map to the public in 2013 (MTA, 2013). Fig.1 also shows the study area on the national seismo-tectonics model. The ICOLD (2016) defined the near-field motion, which is ground motion recorded in the vicinity of a fault. This specification suggested a correlation between the radius of near field area and earthquake magnitude based on the cases in West United States. The author established limits of near-field motion for the investigation area. According to this model, there are eight dams, which are under the near-field motion. The model indicated that earthquakes having a magnitude ( $M_w$ ) between 5.6 and 7.5 can be possible and the minimal distance to the fault segment can range between 1.7 and 121.1 km in the basin. Five existing dams considered in this study are under near-field motion (Table 2).
