Methodology and Evaluation of Large Deformations in Romanesque Pillars

By Josep Lluís I Ginovart, Cinta Lluís-Teruel & Mónica López-Piquer

Universitat Internacional de Catalunya

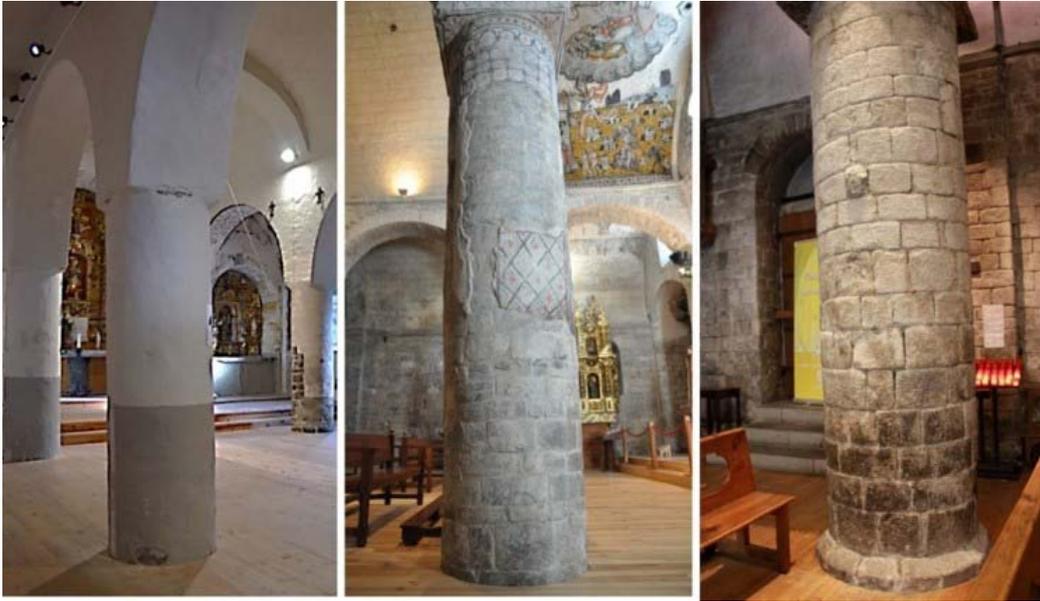
Fig. 1: Deformation of the pillars: Santa Eularia d'Unha, Santa Maria d'Arties and Era Purificacio de Bossost

funicular shapes. One of the reasons of these deformations in Santa Eularia d'Unha, Santa Maria d'Arties and Era Purificacio de Bossost is the displacement of the pillars since they are the least rigid elements of the structure (figure 1).

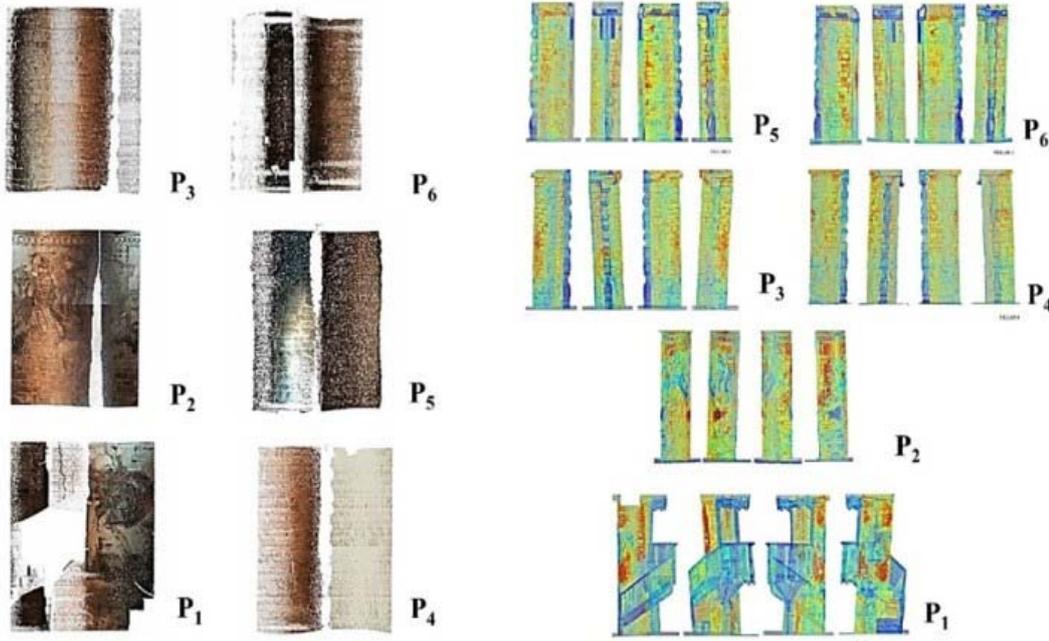
Fig. 2: Visualization of Santa María's pillars: a) Software Cyclone; b) Software Undet

dimensional mesh with an average distance of points of 0.05 m as well as a measure of the triangle for detecting 0.1m holes. The model of the interior of the building has 80.582 points and 156.449 triangles, and the exterior has 314.650 points and 609.472 triangles (figure2a).

points in coordinates (x, y, z) ranging from 0,06 to 0,09 m. (figure 2.b).

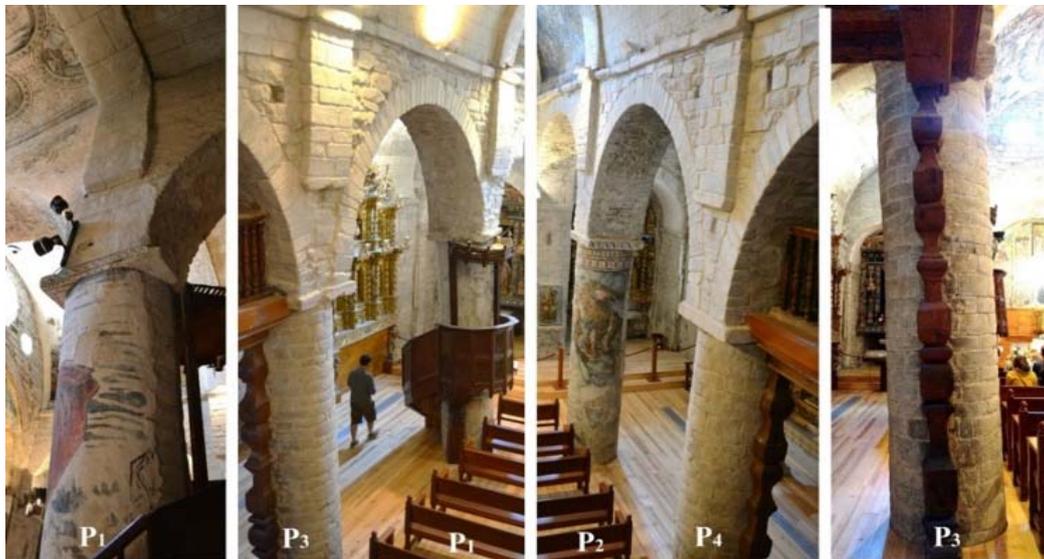
Fig. 3: Geometrical characteristics of the 6 pillars [P1...P6] of Santa Maria d'Artes

The methodology of this study focuses on the assessment of the geometrical characteristics of the six pillars [P1...P6] of Santa Maria d'Artes with the objective of studying the displacements that they have suffered (figure 3). The pillars of the central nave have deformed in a specific way, namely, through the masonry joints (ns). These joints are perfectly visible on pillars P3, P4, P5 and P6, while they are more difficult to visualize on P1 and P2 since they are partially covered by mural paintings. The displacement of a particle in Cartesian coordinates (x, y, z) with its corresponding orthonormal base ($\hat{e}_1, \hat{e}_2, \hat{e}_3$) starts from a reference configuration Ω_0 , where the position vector (X) of a particle G (corresponding to the center of gravity) in space is defined by the material coordinates; $X = X_1 \hat{e}_1$

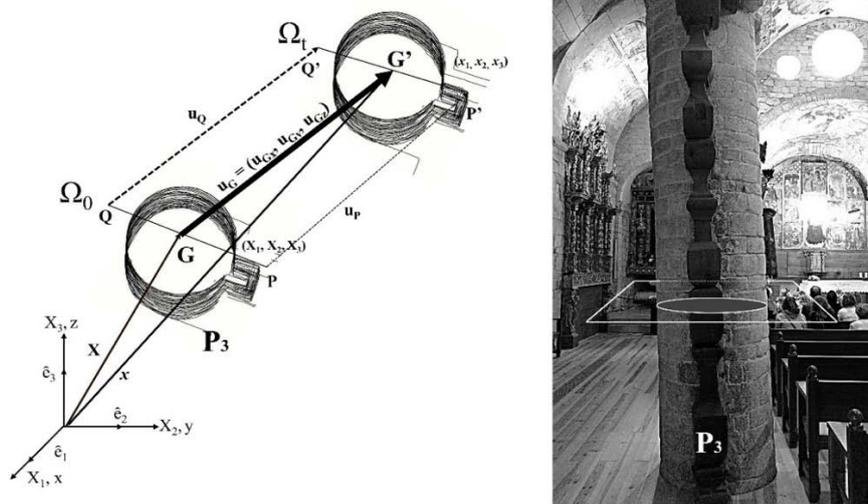
Fig. 4: Displacement of the center of gravity in the section of the pillar P3 of Santa Maria d'Artes

+ $X_2 \hat{e}_2 + X_3 \hat{e}_3 = X_i \hat{e}_i$; (x1, x2, x3). When moving to the current configuration Ω_t , occupying spatial point G', the position vector (x) in spatial coordinates at a snapshot of time (t) will be given by $X' = X'_1 \hat{e}_1 + X'_2 \hat{e}_2 + X'_3 \hat{e}_3 = X'_i \hat{e}_i$; (x1, x2, x3). This change in position is represented by a displacement vector, $u_G = (u_{Gx}, u_{Gy}, u_{Gz})$ (figure 4).

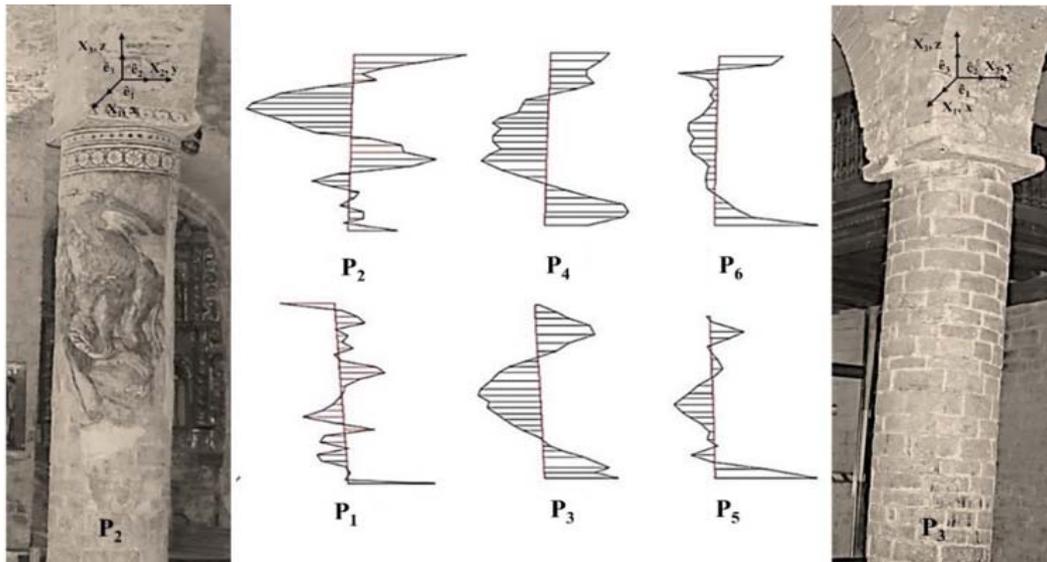
Fig. 6: Representation of displacements on the regression planes P_{ri} over (y)

coordinates (xci, yci, zci) are set for each section (ns). The centroid of reference (xc0, yc0, zc0) is set in the section of the floor plan since it would have not suffered any displacement (figure 6).

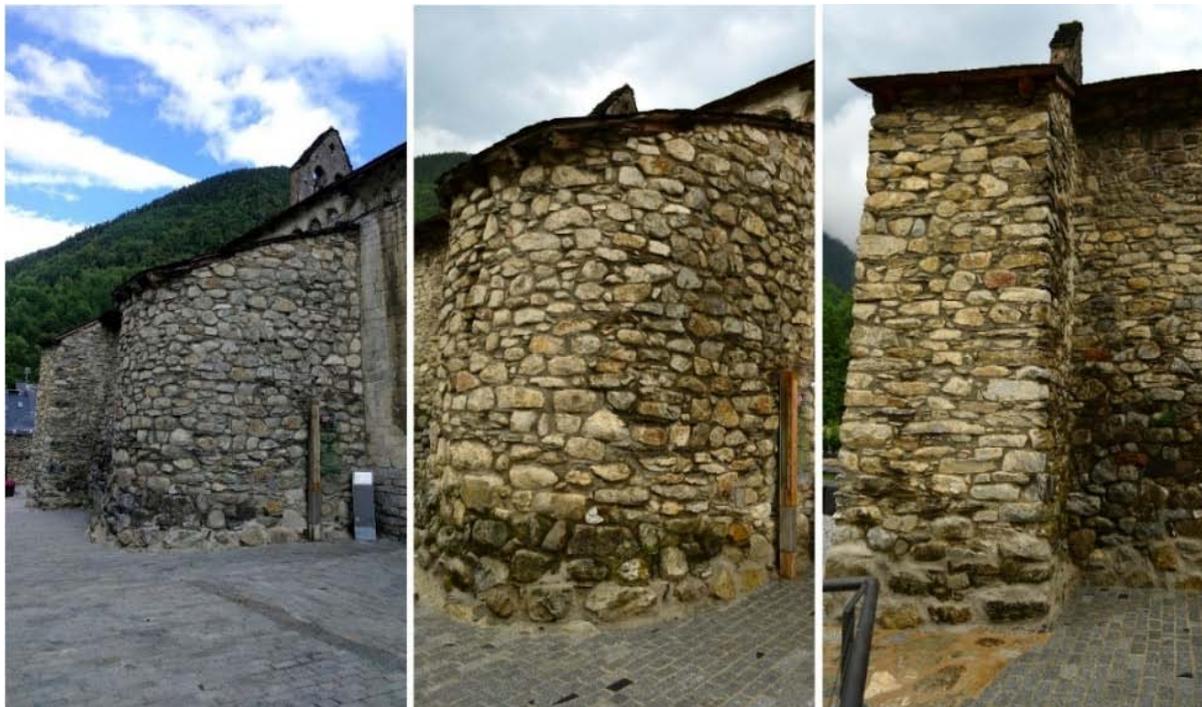
Fig. 6: Passive thrusts of the buttressing elements, walls (Emp) and buttresses (Emc)

The reparation and containment of these deformations are the cause of the reinforcement of the perimeter walls by means of the construction of buttresses or strategical placement of bell towers, which are usually built in the opposite façade to the apse. The active thrusts (Eba) of the vaults over pillars and walls have been determined, but to understand the equilibrium of these constructions, it is essential to understand the passive thrusts of the buttressing elements, walls (Emp) and buttresses (Emc). Due to these thrusts, some vaults have deformed towards funicular shapes (figure 7).

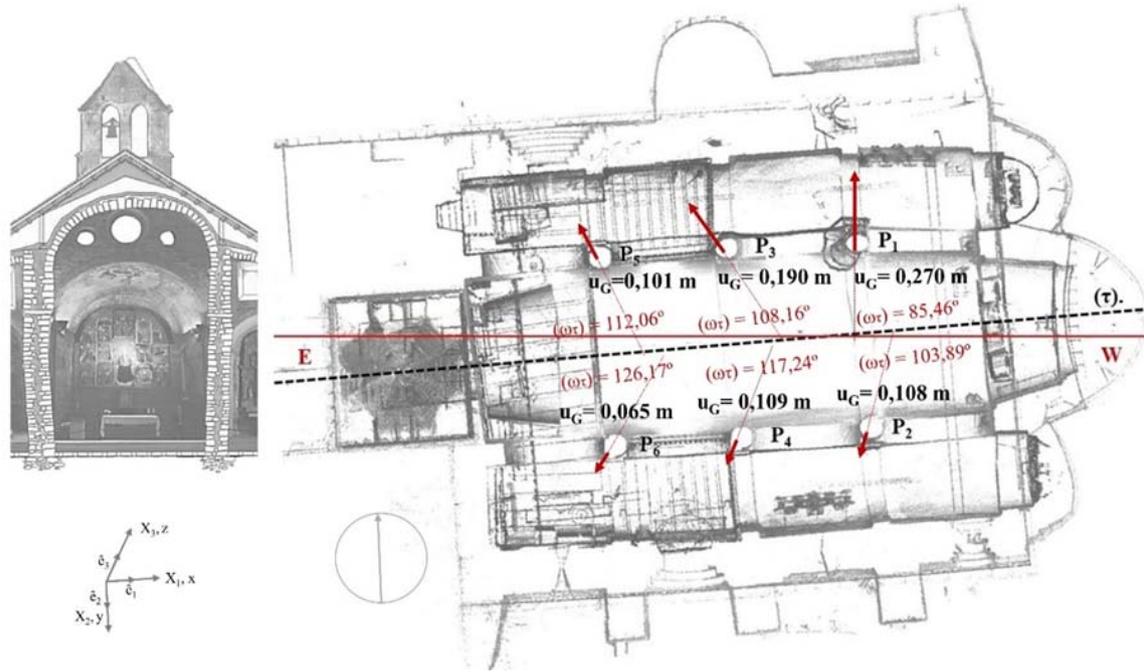
Fig. 8: Characterization of the regression planes P_{ri} from Cyclone (2016)

The greatest displacement is found in pillar P1, with a range of displacement on each row of [0.270, 0.001]. This displacement is followed by that in pillar P3, with a range of [0.190 – 0.001]. The range of displacements of the rest of the pillars is as follows: P2 [0.108 – 0.002], P4 [0.109 – 0.002], P5 [0.101 – 0.001], and, finally, the least deformed pillar, P6 [0.065 – 0.001].

Thus, pillars P1, P3 and P5 have greater deformations than the others. None of the regression planes P_{ri} is perpendicular to the axis of the central vault. Each one is moderately sloped. The angle in P1 is 85.466° , so $(\omega \phi) < 90^\circ$. It is also the most inclined pillar (0.270 m) and is

the highest (4.170 m). The rest of the pillars have angles $(\omega \phi) > 90^\circ$ with a range $[103.893^\circ - 126.169^\circ]$; [P2; 103.893°], [P3; 108.665°], [P4; 117.245°], [P5; 112.066°] and [P6; 126.169°] (figure 8).

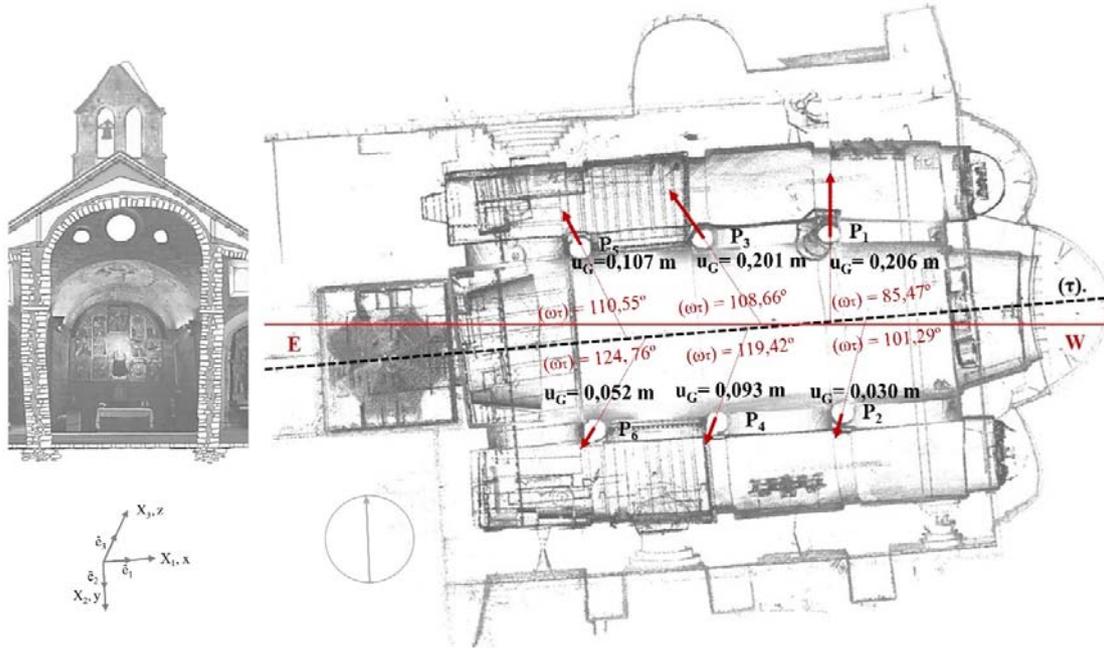
Fig. 9: Characterization of the regression planes P_{ri} from the plugin Undet

deformation of P2 the biggest difference (2.599° less) and the one of P3 the smallest (0.003° less). The angle in P1 is 85.474° , so $(\omega \phi) < 90^\circ$, and it is also the most inclined pillar (0.206 m). The rest of the pillars have angles $(\omega \phi) > 90^\circ$, as we have previously seen, with a range $[101.291^\circ - 124.756^\circ]$: [P2; 103.893°], [P3; 108.657°], [P4; 119.417°], [P5; 124.756°] and [P6; 110.553°] (figure 9).

We have also seen that the deformations of P4 and P5 are bigger in the middle of pillars height than at the top of it. With Cyclone we did not find those deformations. The obtained results from both methods used are very similar to determine deformations in Romanesque masonry buildings, where the interest of the displacements is more qualitative than a quantitative order of magnitude. The graphic precision of the plugin Undet for Google SketchUp 2019 should be noticed, since it is higher and, therefore, allows the identification of the masonry joints of the pillars that each point composing the point-cloud extracts from the Terrestrial Laser Scanner (TLS). To work with this plugin, there is no need to have a computer with a lot of graphic capacity, and the point-cloud can be sectioned in few seconds. Regarding to its precision, in a section of 0.005 m, the error is about 0.006 m (0.030%), unlike the one obtained from the software Cyclone (2016), which was 0.03m.

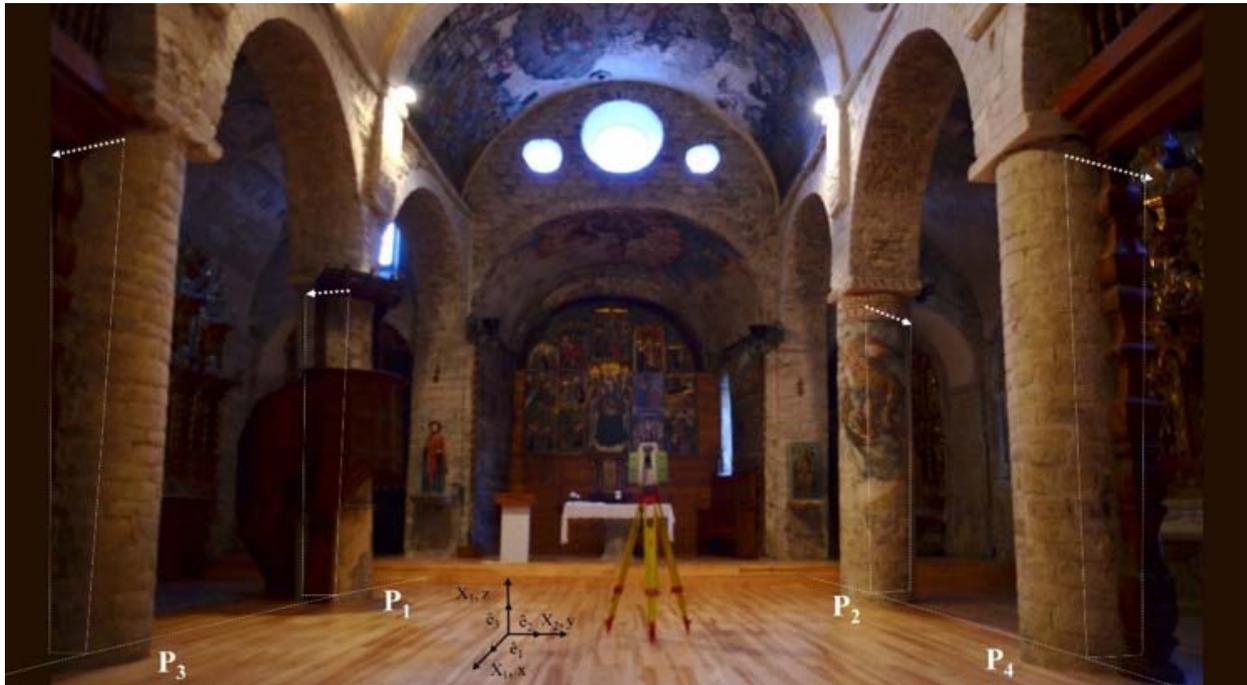
Fig. 10: Vectorization of the displacements of each row from the regression plane

The obtained regression planes P_{ri} , which contain the deformations d_{fp} (d_{fpx} , d_{fpy} , d_{fpz}) for each pillar, tend to have the direction of the thrust over the pillar P_i . These displacements are the result of the active thrusts of vaults $[(E)_{ba}]$ and the passive thrusts of the buttressing system, walls $[(E)_{mp}]$ and buttresses $(E)_{mc}$. This study revealed that the direction of the displacements of the six pillars P_i is not perpendicular to the central axis of the church ϕ_1 , since $(\omega\phi) \neq 90^\circ$. This result proves the hypothesis that the thrusts of the vaults are not perpendicular to the axis of the church, as was the case of Roman vaults, which Choisy (1873) [27] defined with regular geometry and stone cutting. The direction of displacements is caused by the irregular geometry of the vaults of Santa Maria d'Arties as well as the masonry stone cutting and the above-mentioned passive thrusts of the walls and buttresses. The last ones were placed to maintain equilibrium during the last millennium (figure 10).
