Methodological Strategies for the Reconstruction and Sustainable Improvement of the Habitat of Localities in the State of Chiapas, Mexico

By Lorenzo Franco Escamiroso Montalvo, María de Lourdes Ocampo García,
Carlos Uriel del Carpio Penagos & Sergio Naraín Zebadúa Velasco

University of Chiapas

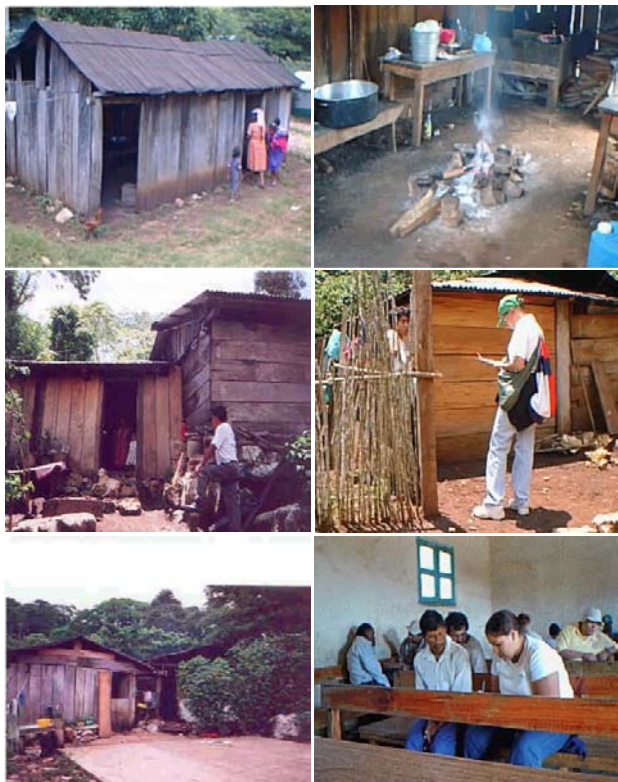
Image 4: Indigenous housing in precarious condition

Agriculture is the main economic activity, they grow coffee, corn and beans. In study, 3 main problems were identified: Access road (2.2 km of road in poor condition), health service (clinic, with only a medical assistant and midwife) and agricultural production-marketing (lack of transport). Of the houses: 34.6% in floor of soil, 64.4% do not have sanitary furniture, more than 30% do not have sanitary furniture or body grooming area, etc. (see image 4). The source of water supply is a spring, the water is not drinkable and is supplied by surface hoses, they have no sanitary drainage network or public cleaning service, among others (see image 4).

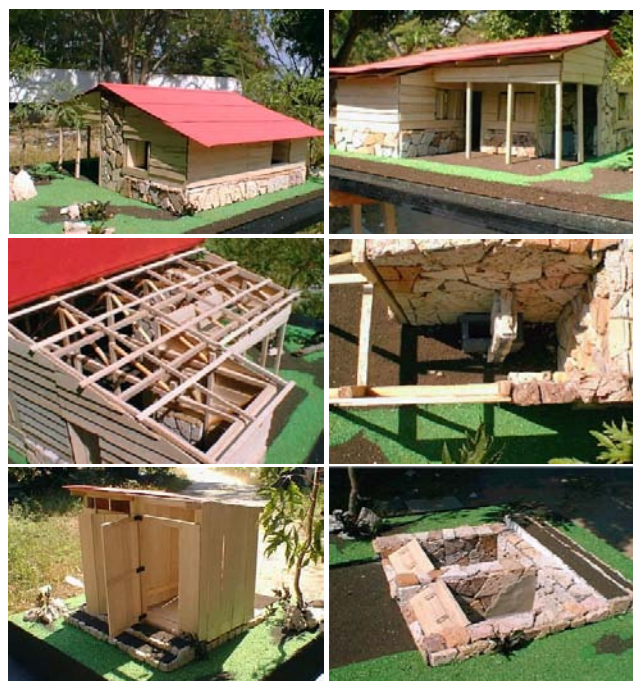
Image 5: Proposed alternative housing with local materials

The proposed house (see image 5), was developed based on existing materials and environmental conditions: 1) The wooden walls of the original house, if the quality of the material allows, thus recycling the existing wood; Also, the walls are supported on a low wall built of stone: 40 cm wide, 50 cm high and 40 cm deep (foundation), to prevent deterioration by moisture, 2) The structure of the walls and roof, will be made of wood and the roof of sheet-zinc placed on a thermal layer, to conserve or isolate the heat , 3) A bathroom with tank to store water, for the purpose of dignifying the body grooming of women, 4) A dry latrine of 2 chambers.

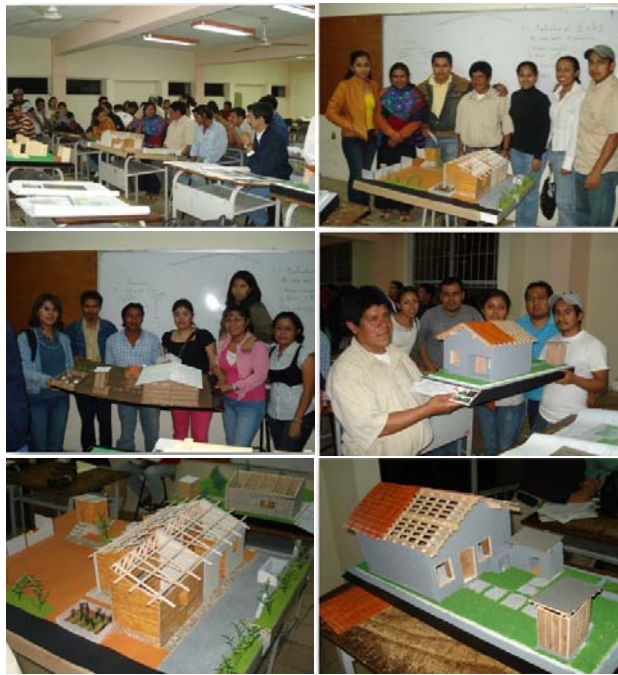
Image 6: Presentation of housing prototypes to indigenous communities

- On 3 December 2008, CADU members, students and community representatives met: *Ichilho*, *Jolnajojtic*, Monte Bonito and *YutU'Kum* of Chamula municipality and *Ajtectic Bajo*, *Pij*, *Gechvó* and *Chajtoj* de Zinacantán, with the purpose of presenting and delivering 8 alternative housing proposals prepared by architecture students,

advised by teachers-researchers; this activity was carried out to interact with the inhabitants and representatives of the communities, and, with it, listen to their comments, in relation to the prototypes of housing, which includes dry latrines, water storage tank, among others (see image 6).

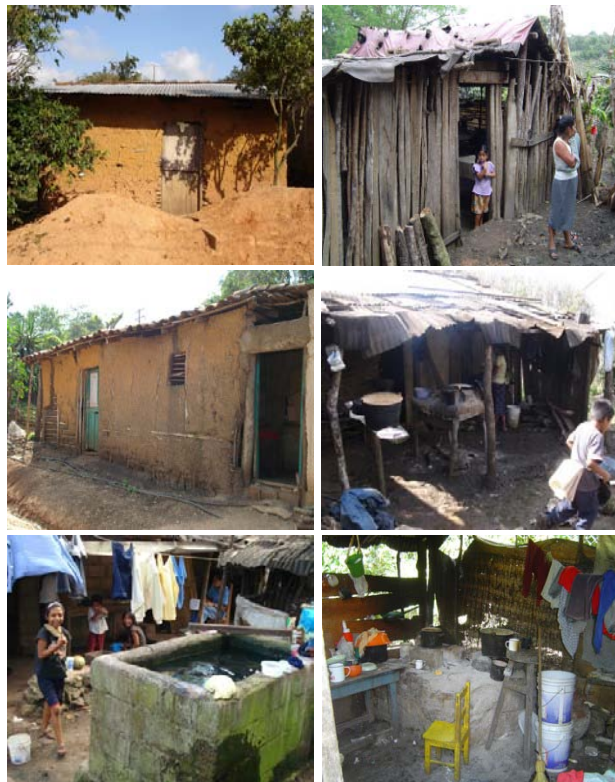
Image 7: Precarious homes in Ocuilapa

The research carried out in the ejido Ocuilapa de Juárez, municipality Ocozocoautla, was funded by Fomix-CONACYT (2006-2008) and UNACH. The objectives set were: to carry out the diagnosis of housing and to develop prototypes appropriate to the characteristics and social conditions of the community. Analyses identified that 13% of homes are in precarious condition (see image 7), 80% with masonry walls built with concrete block parts with 2 holes, confined vertically with steel only at the intersections of walls and in the perimeter a dala; However, 77% of the condition of the structure of the houses is poor (R4), there are cracks in the spaces of doors and windows. Problems are attributed to the use of sand with 22% clay, technical deficiency in construction, etc.

material, 2% palm and 67% sheet-zinc; of these, 40% of the structure has various "R4" problems; In addition, the sheet covers have no insulators, which generates unfavorable thermal variation inside: cold and heat.

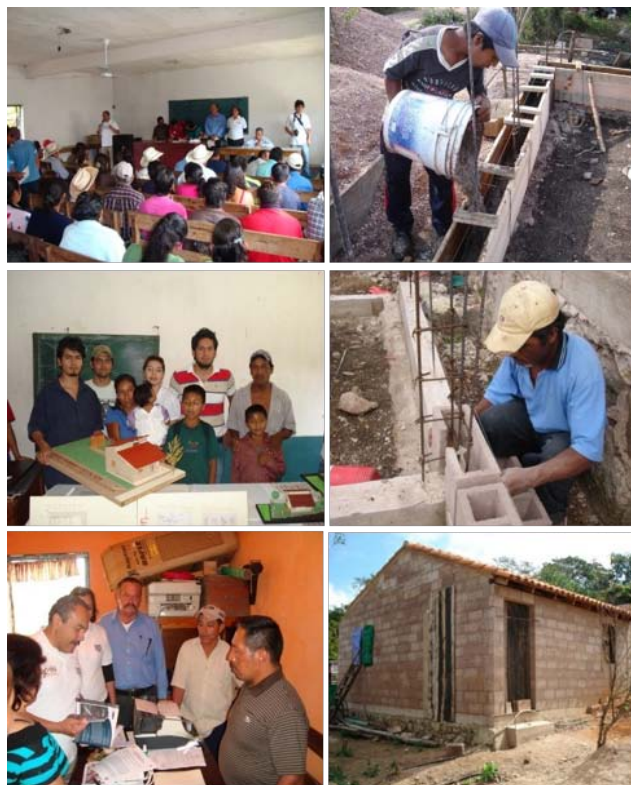
Image 9: Alternative housing for Ocuilapa

Image 9 shows the meeting with farmers from Ocuilapa, where architecture students presented prototype models, to listen to family feedback and make decisions in the configuration of homes. The construction plans of the homes that were built by 5 families were then developed, with the technical assistance of the team. The proposed walls with concrete blocks with 3 holes were reinforced with steel inside; vertical and horizontal senses, based on technical standards. The sand of the place that has 22% clay was used, due to the usual use of this material, as well as its availability and low cost. The technical information was integrated into a self-construction manual that was delivered to the ejidal representative (Escamiroso, *et al*, 2017).

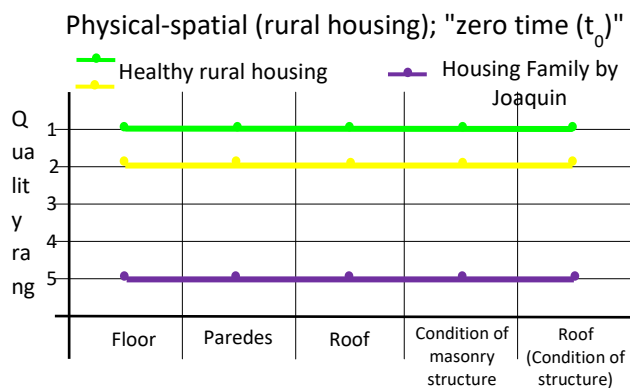
Image 10: Graph of record in "zero time" condition of the house

With the MACVE model, it is also possible to obtain the individual analysis of the house and its surroundings. The image shows some records in the "zero time (t_0)", of Joaquín's family home (see image 12). The walls, ceiling and structural, were in critical condition, "R5" (Very bad).

Identified the elements to be transformed (image10), Joaquín's family built their home in 10 months, which included training, advising and supervising the work, which ended in "time one (t_1)". The research project financed the materials used: cement, reinforcing steel, etc. The labor, for the extraction of stone and sand from the place and the construction, was in charge of the family.

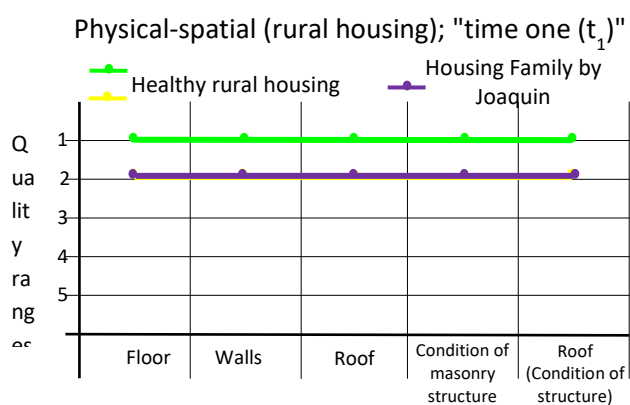
Image 11: Record chart in "time one" condition of the house

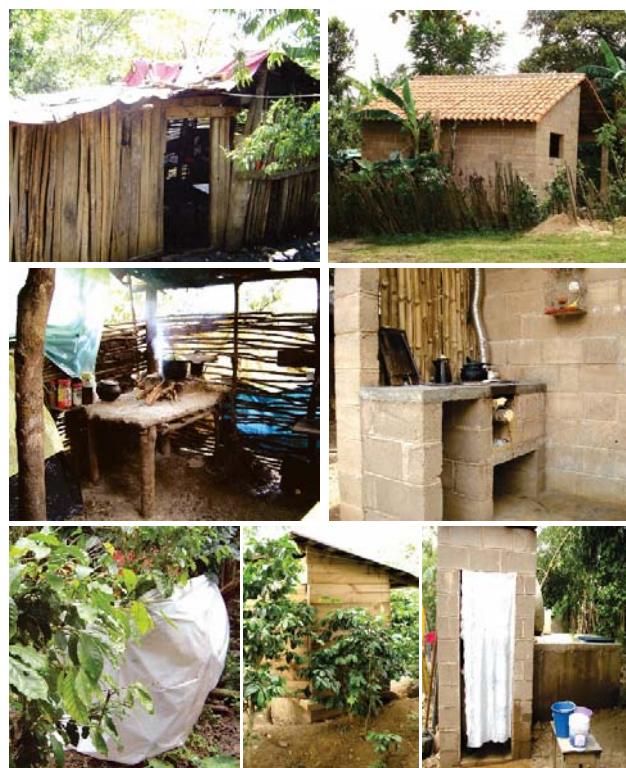
Image 12: Housing before and after the intervention

The home of Joaquín Hernández, his wife Norbel Jiménez and their two children, during construction received no financial support, as it was a commitment raised from the beginning. Image 12 shows the housing conditions before and after the intervention: "zero time (t_0)" and "time one (t_1)", respectively. The house has 2 bedrooms, living room, dining room, on 36 m² of surface, plus an ecological stove, dry latrine with 2 chambers and bathroom with water storage tank. Also, the seismic-resistant capacity of housing built with concrete block walls with 3 holes was assessed and resulted from "low vulnerability", indicating that the walls have good resistance in cases of seismic action (Escamirosa, *et al*, 2017 and 2018).

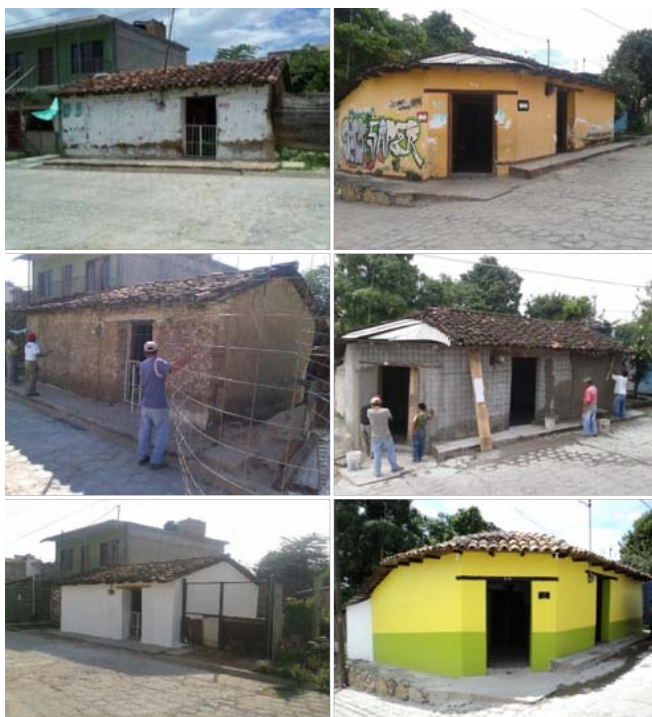
Image 13: Structural intervention in 2 adobe homes in Chiapa de Corzo

In the town of Chiapa de Corzo, the research project was carried out: "Proposal for structural strengthening for the consolidation of traditional housing...", funded by PROMEP-SEP (2013-2015) and the objective was to contribute to the conservation of traditional adobe homes and increase structural security. The proposal was to reinforce the walls with a concrete membrane of 2 cm and steel mesh (electrowelded mesh 6x6/10x10). In Image 13, you can see the houses and their initial conditions (zero time), the construction process and the completion (time one). The work carried out did not require specialized labor, only one masonry officer and one pawn per dwelling (Escamirosa, *et al*, 2014 and 2019) were employed.

The sism-resistant capacity of the houses of Ocuilapa de Juárez and Chiapa de Corzo, was examined with measurements of accelerographer, analysis and structural modeling with finite elements, and it was determined that the structure was adequate. This fact was corroborated by physically inspecting the dwellings, after the earthquake that occurred off the coast of Chiapas, on September 7, 2017, which had a magnitude of 8.2 on the Richter scale and caused damage and collapsed homes in different locations in Chiapas state. In the structural analyses carried out, the team of researchers of the Academic Corps Natural Risks and Geotechnology (CARNG) of the Autonomous University of Guerrero (UAG) collaborated.
